What We Can Learn from Sailing Accidents to Benefit Sailors

Sally Lindsay Honey, Chair, Safety at Sea Committee

Sailing Incidents

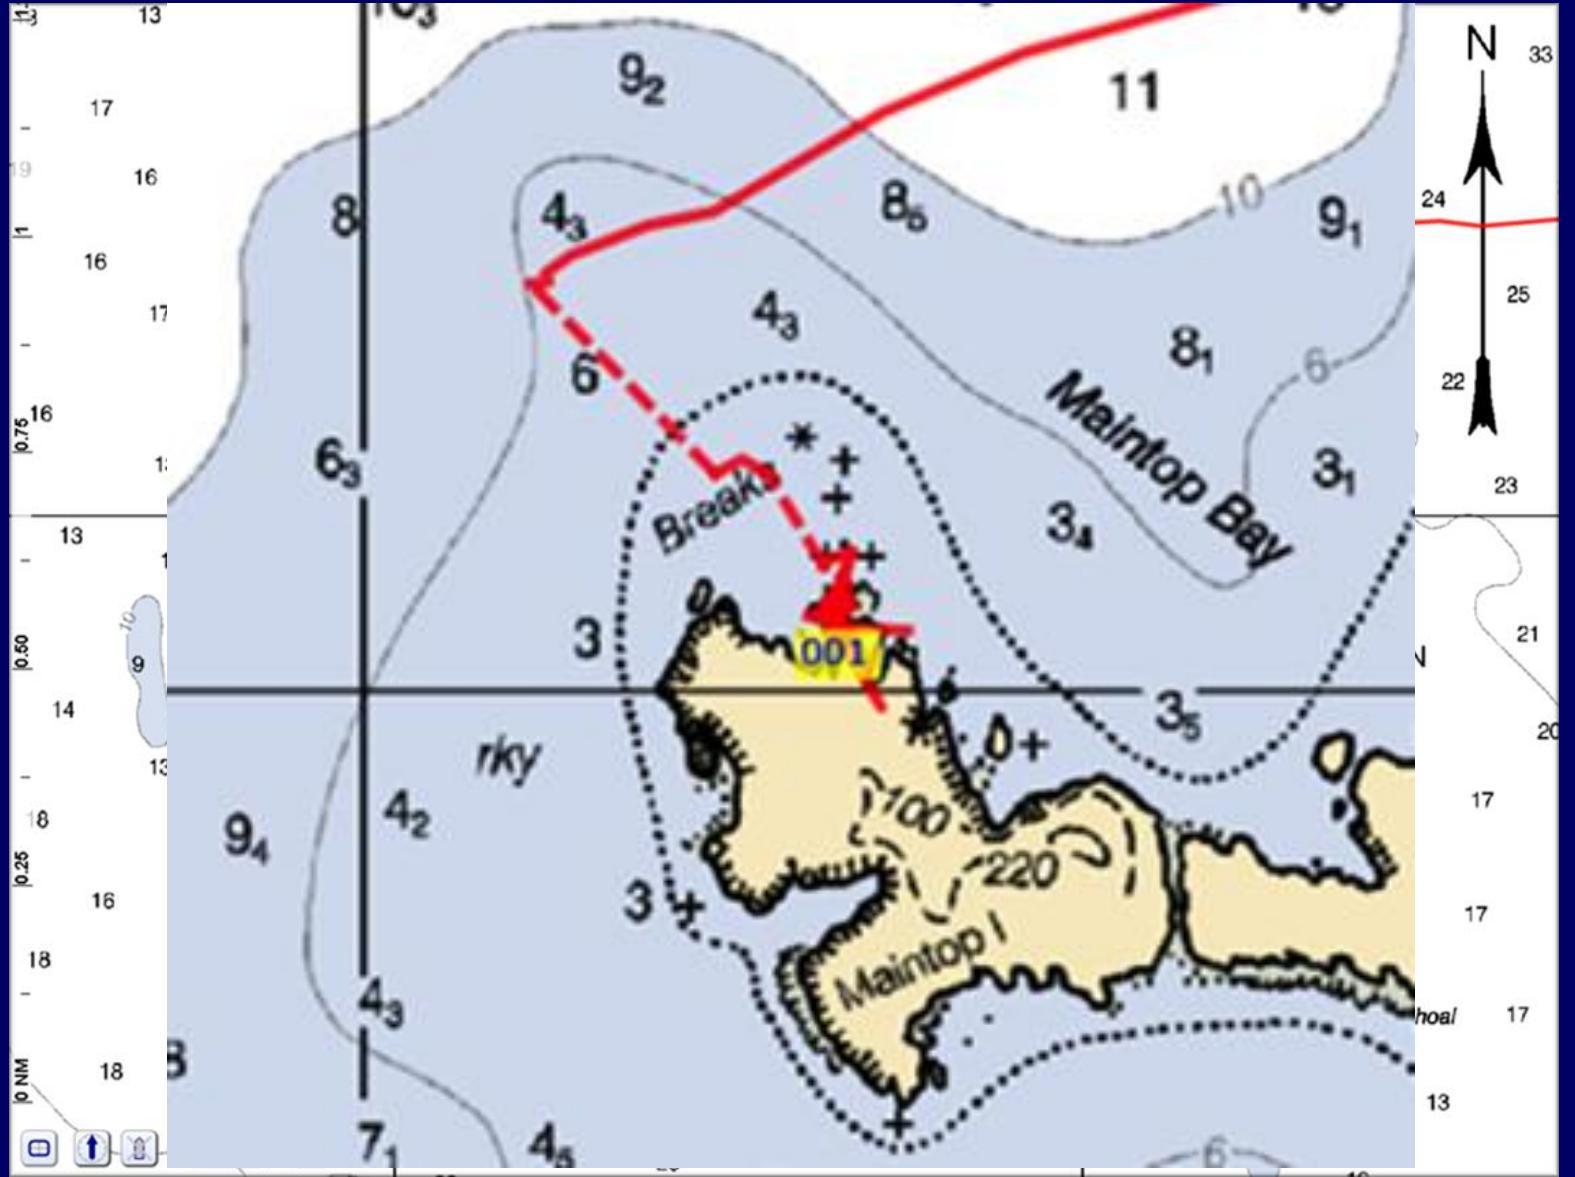
turned tragic:
Breaking wave
Lee Shore
5 of 8 crew lost

Failure of seamanship in negotiating shoal waters on a lee shore

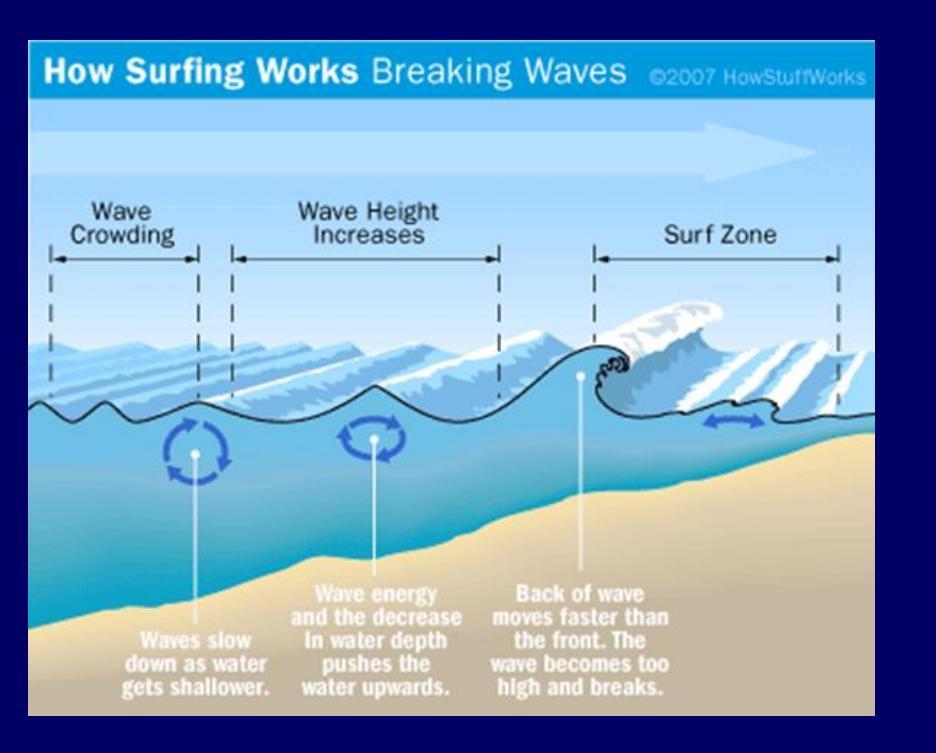
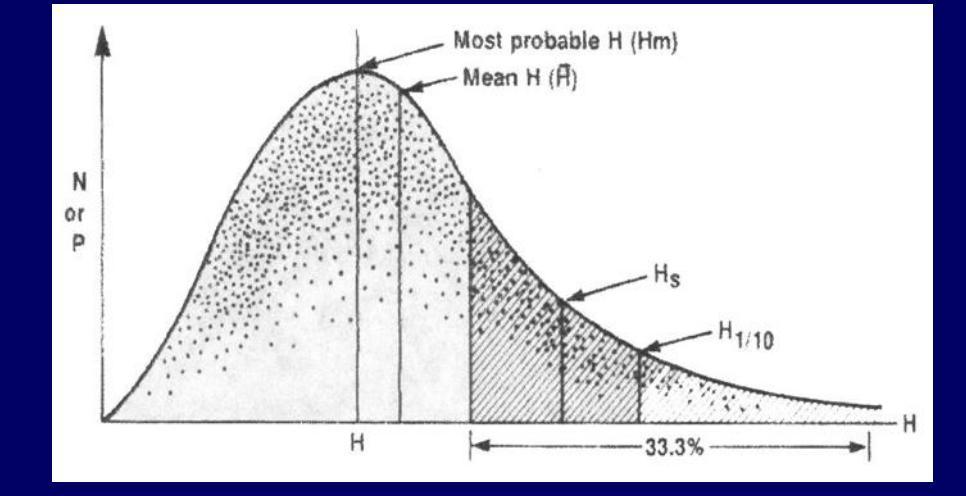
Safe Water Depths:

Significant Wave Height/SWH = *average* of largest 1/3 of all waves. Forecast: wind waves 7' on 15' swell Maximum: 30 feet, 2-3 per hour = 25'

Calculate minimum depth from maximum forecast swell and wind-wave heights: 3 ways

Easiest: 2.5x the sum of maximum forecast swell and wind-wave heights

For April 14th forecast: 1) 43', 2) 55', and 3) 45-60'

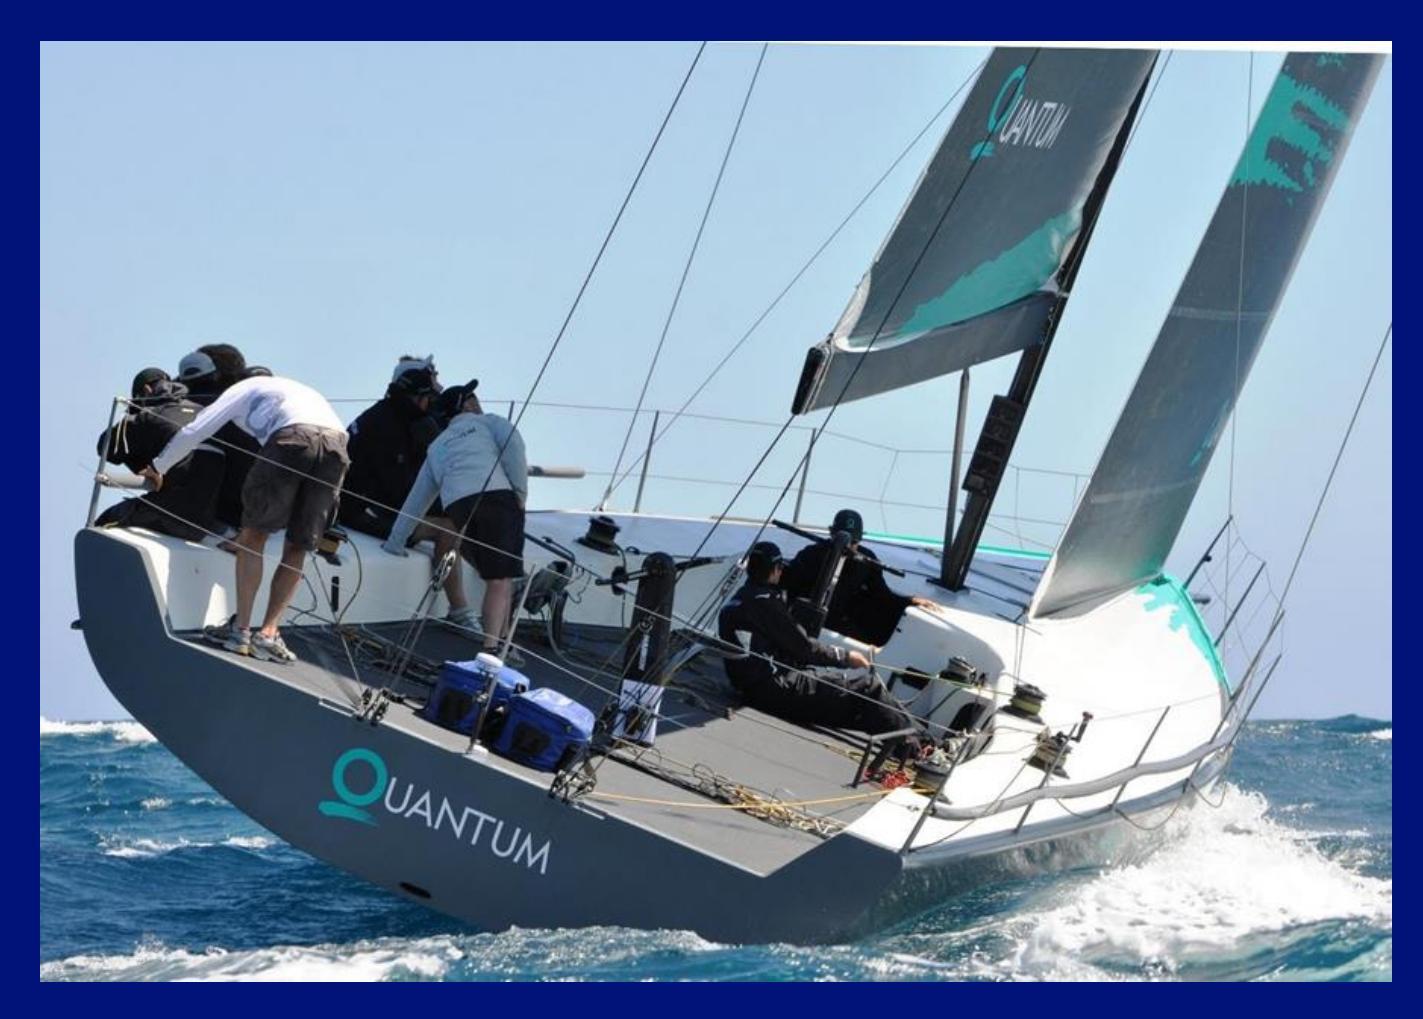
Imedi, TP 52, Chicago- Mackinac Race, 21 July 2018, Jon Santarelli/COB lost

Wide open cockpit: no jack lines near vang control

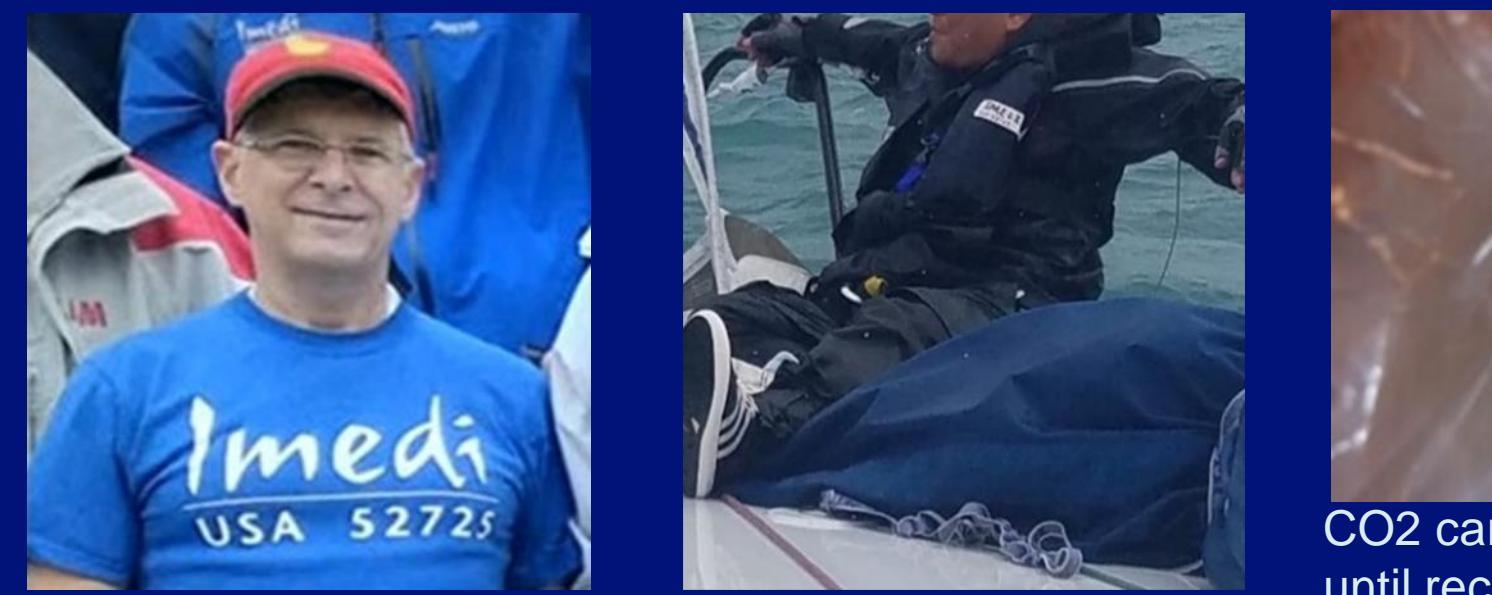
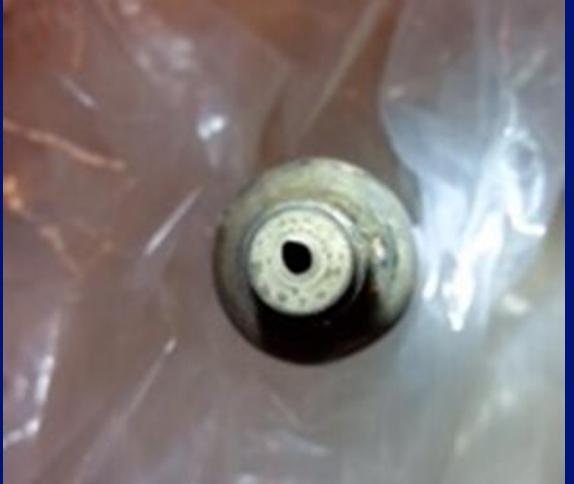
Jon Santarelli was fit, conscious, swimming. Why did he drown?

CO2 cartridge not pierced until recovered 1 week later

- Cursory pre-inspection of 10+ year old life jackets
- Crew not familiar with boat-supplied life jackets
- No attempt by PIW to manually/orally inflate life jacket

- 1. Comprehensive Dock Talk: command structure, crew roles, procedures
- 2. Establish/communicate COB procedures
- 3. Safety gear: Inspect, fit, instruct prior to use
- 4. Practice in expected conditions
- 5. As PIW: act immediately
- 6. Enhanced training needed for inflatable lifejackets

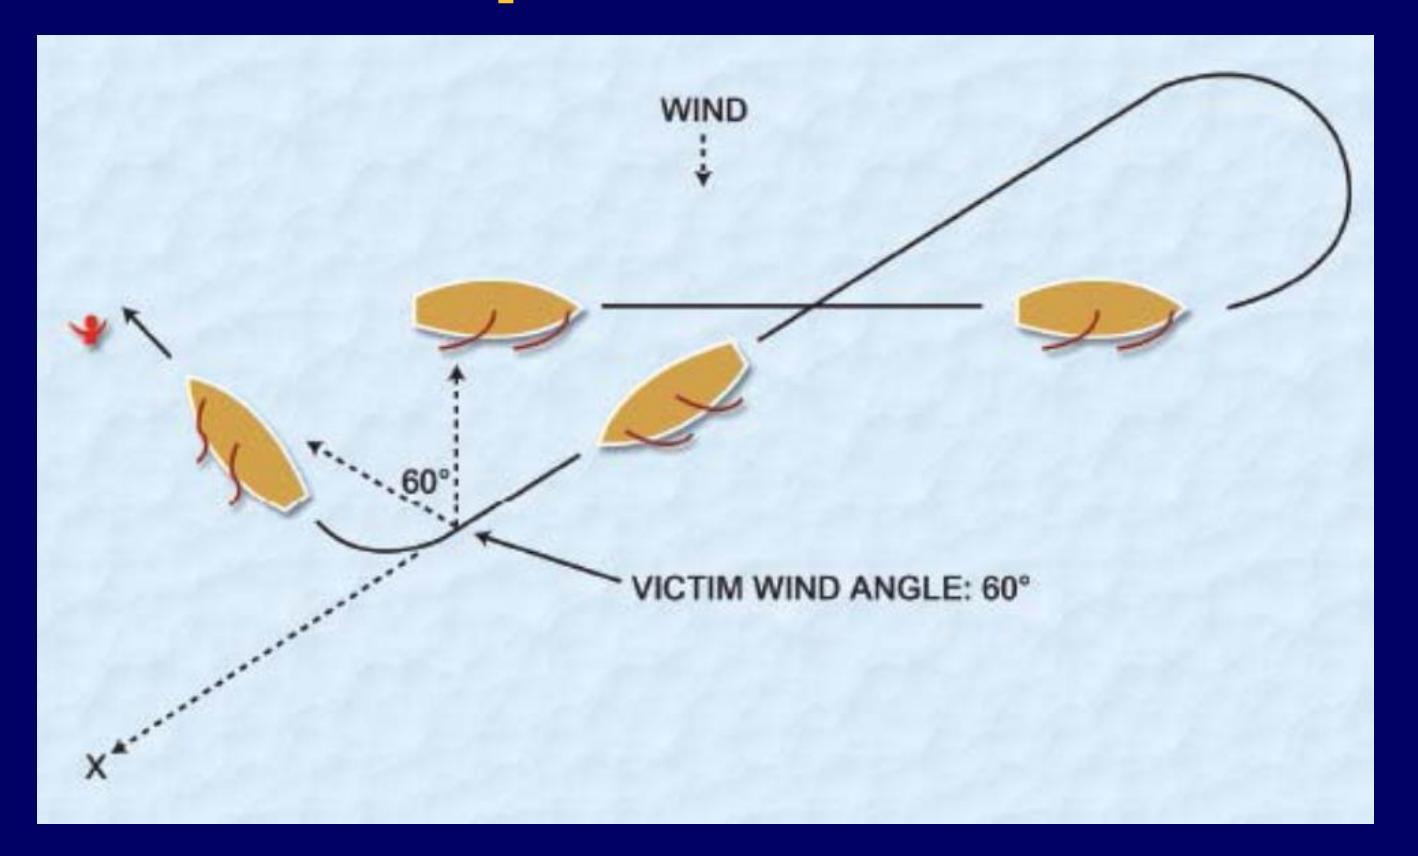
Recovery Attempts, Morpheus crew:

Figure 8, twice. Lost grip: "Hurry" Threw line, upwind, Dale falls in

Stay attached to boat Consider use of lifelines Cause of death: drowning due to inadequate flotation Use of Lifesling could have provided flotation Crisis stress > additional people in water Cold water acts quickly

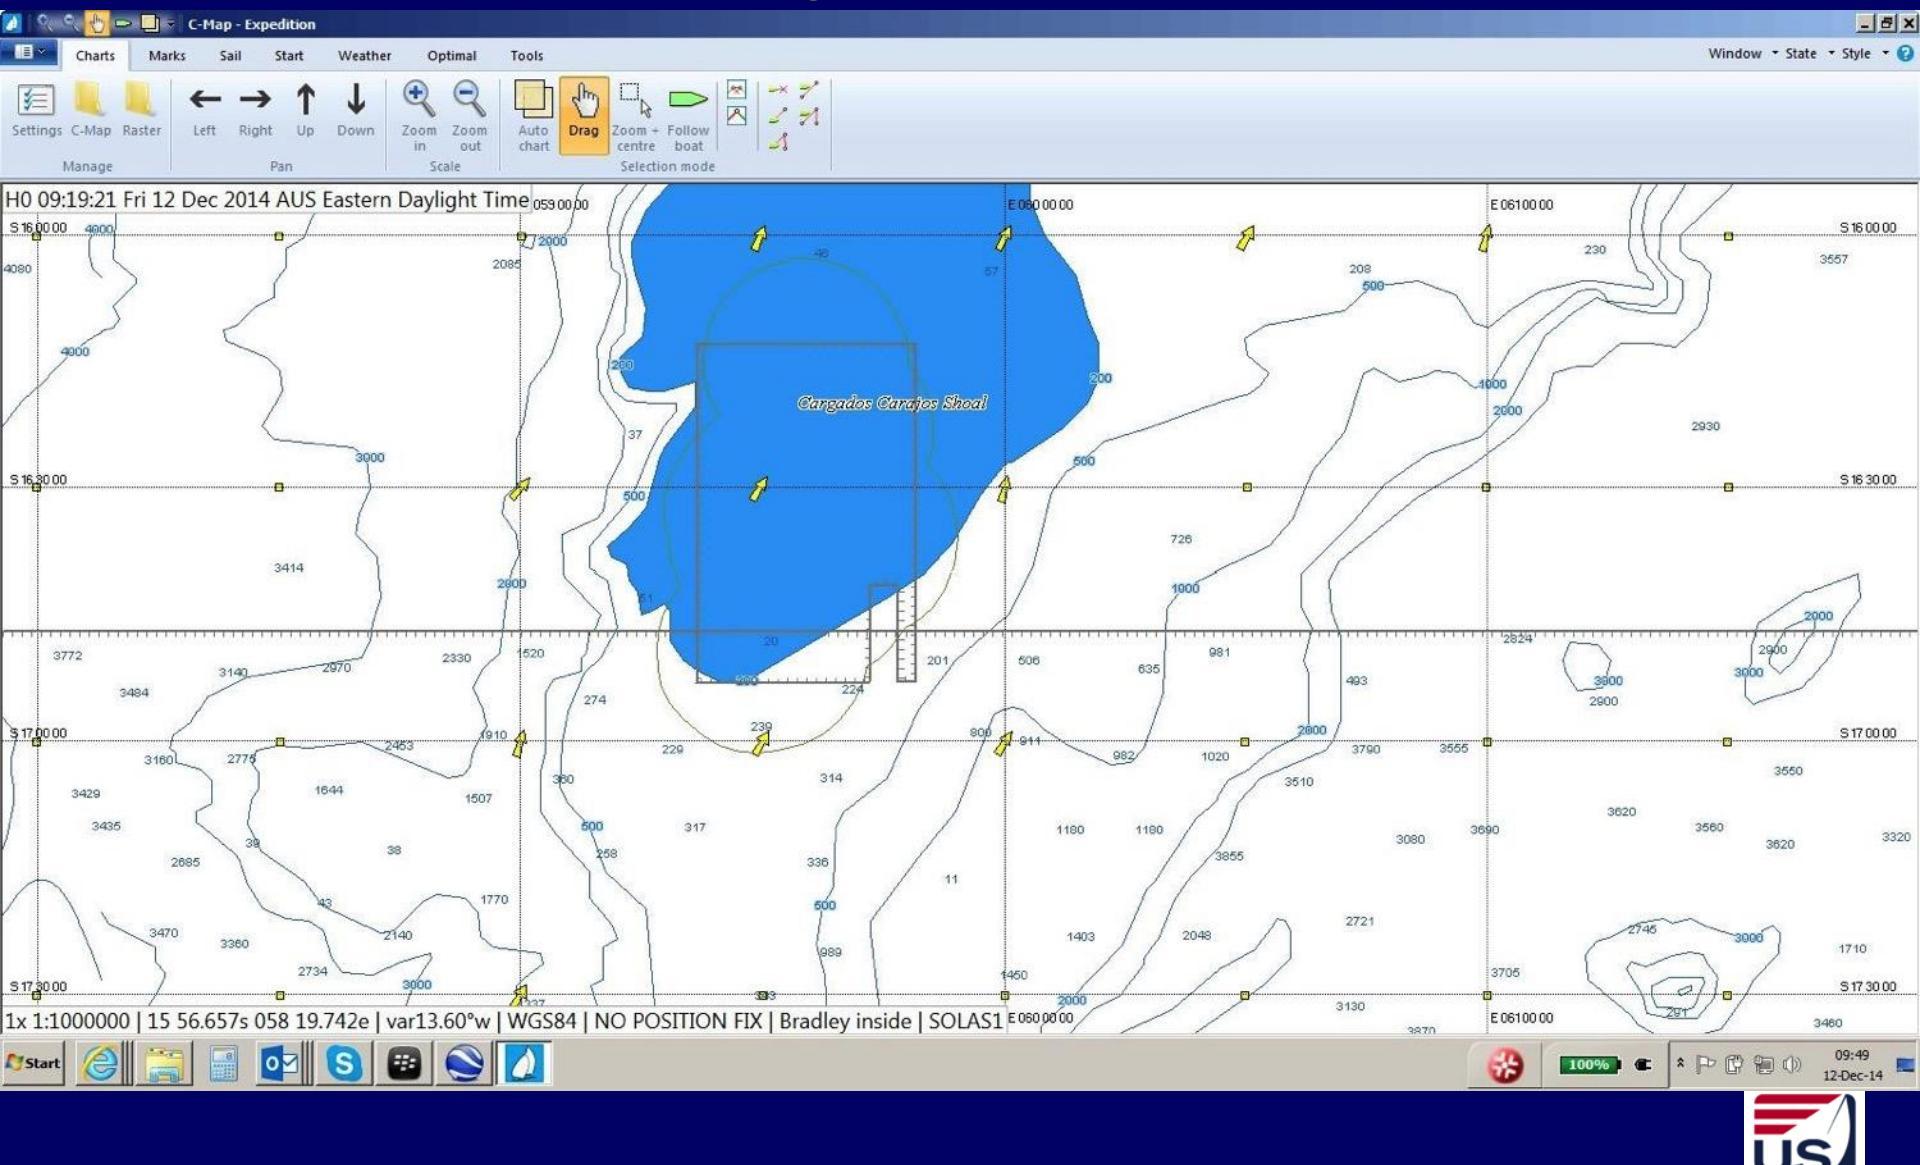
Big blue area showing depths less than 200m

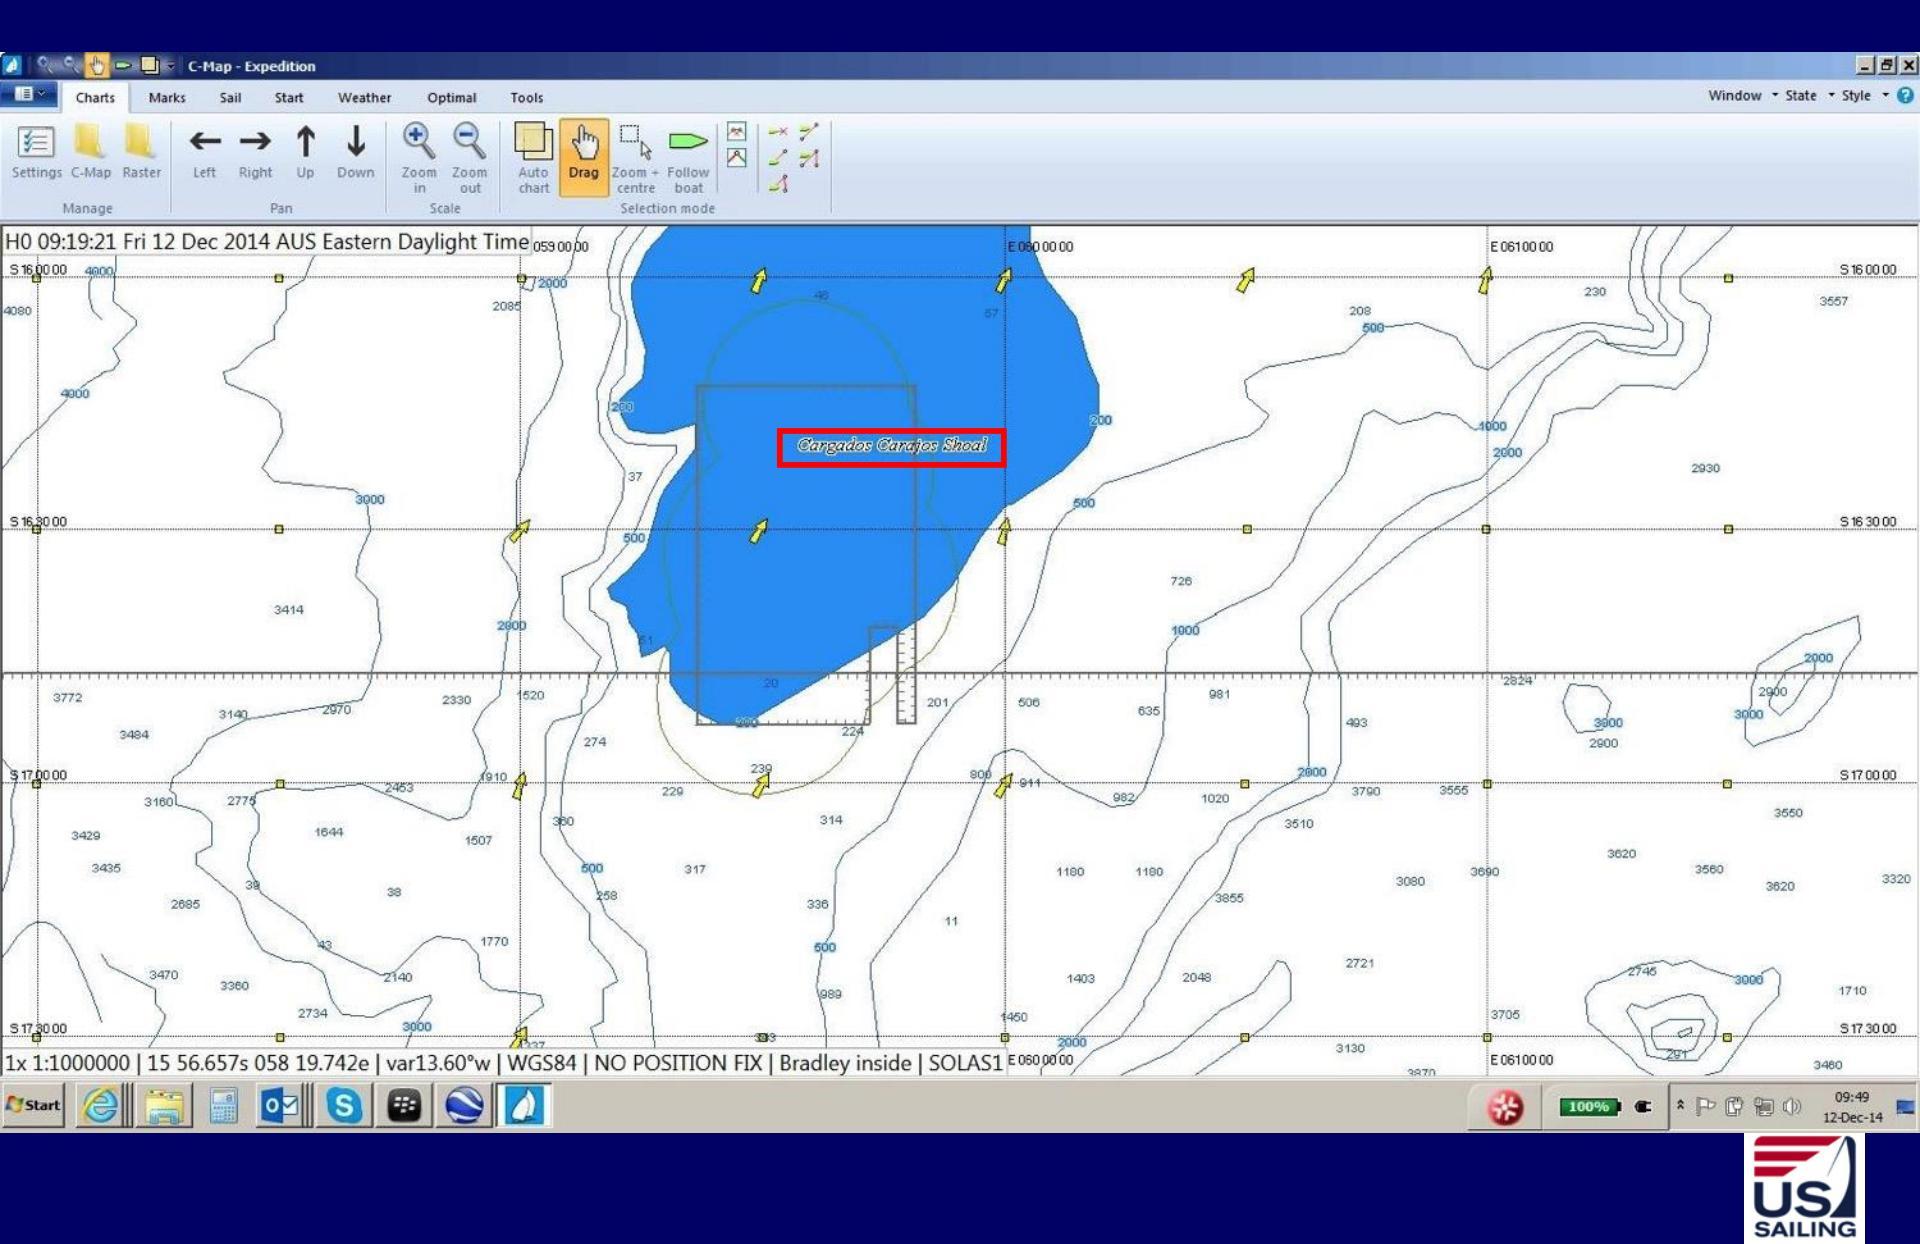
A name of a physical feature with "shoal" in it

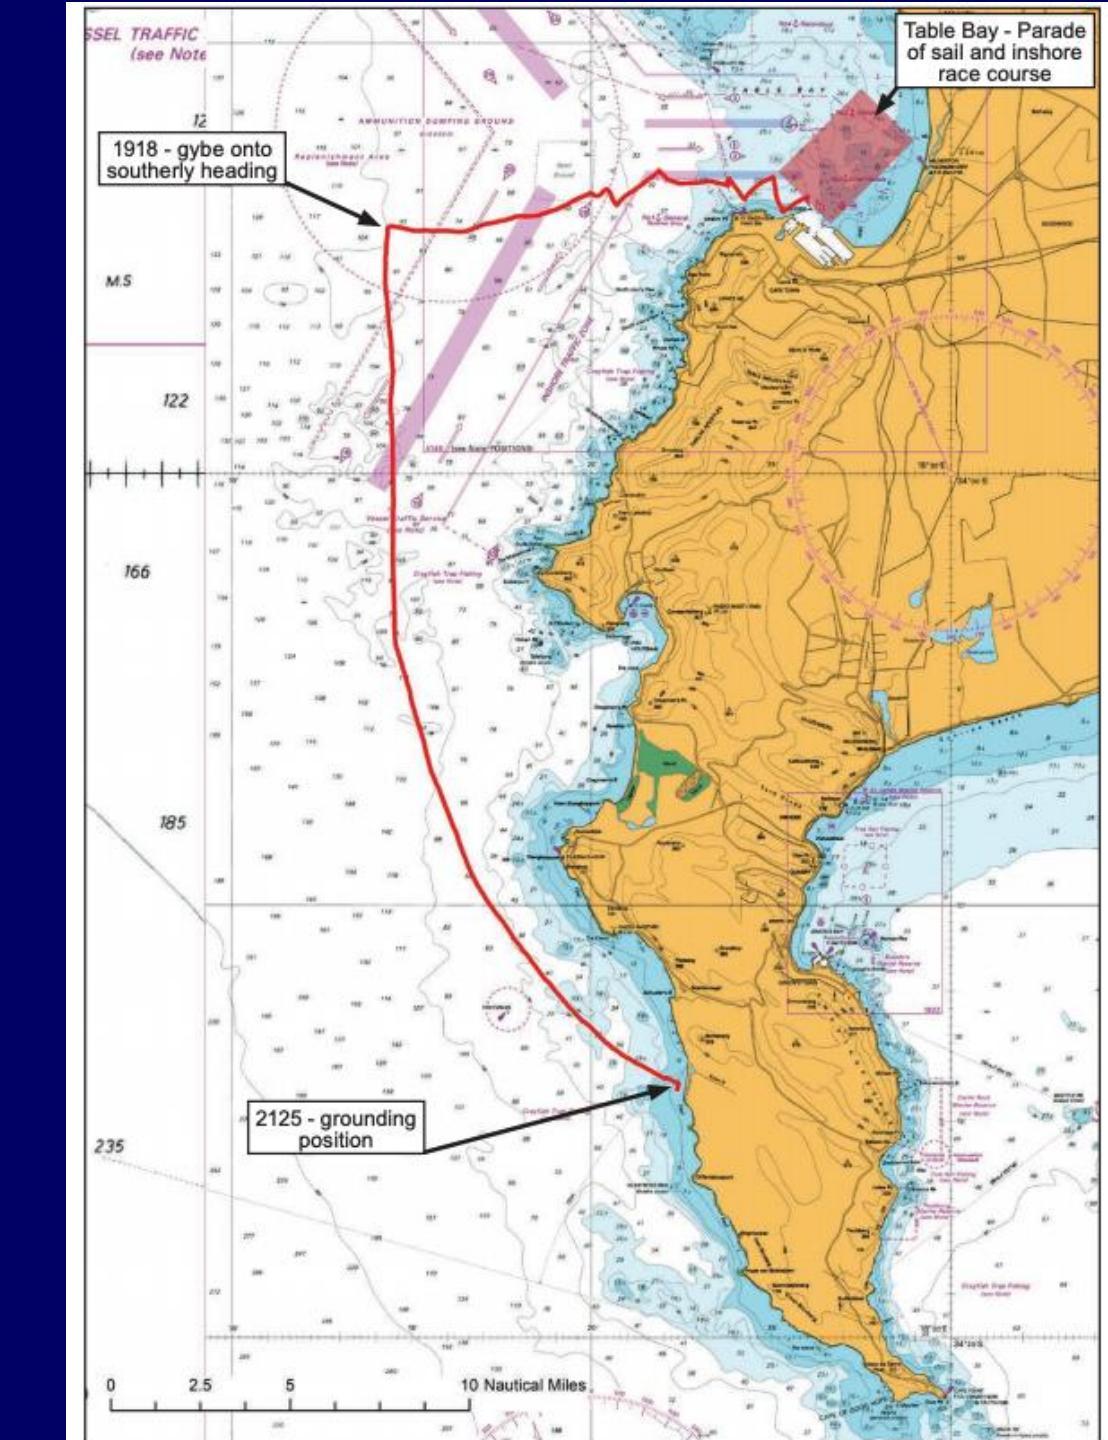
Path of CV24 from the start of Leg 3, along Cape Peninsula

Winds initially out of the NE; began to back as fleet went south.

Breeze freshened from the north, then NNW

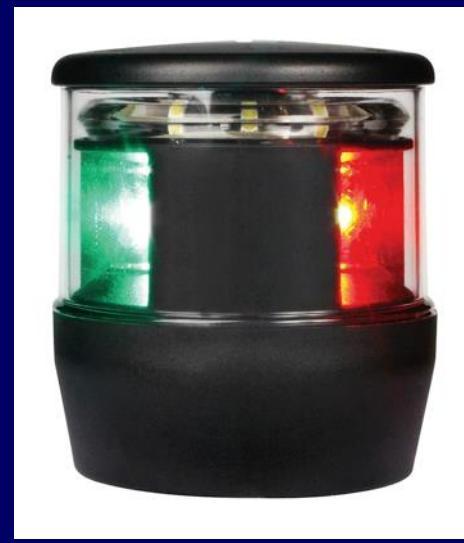
Navigation light conundrum

Up to 20m, vessels can use a combined nav light at the masthead for sailing

Above 20m, separate sidelights and a sternlight

Cannot be used under power, necessitating additional lights

Lights at the sheerline are blocked by sails

Lights on the prod are frequently underwater

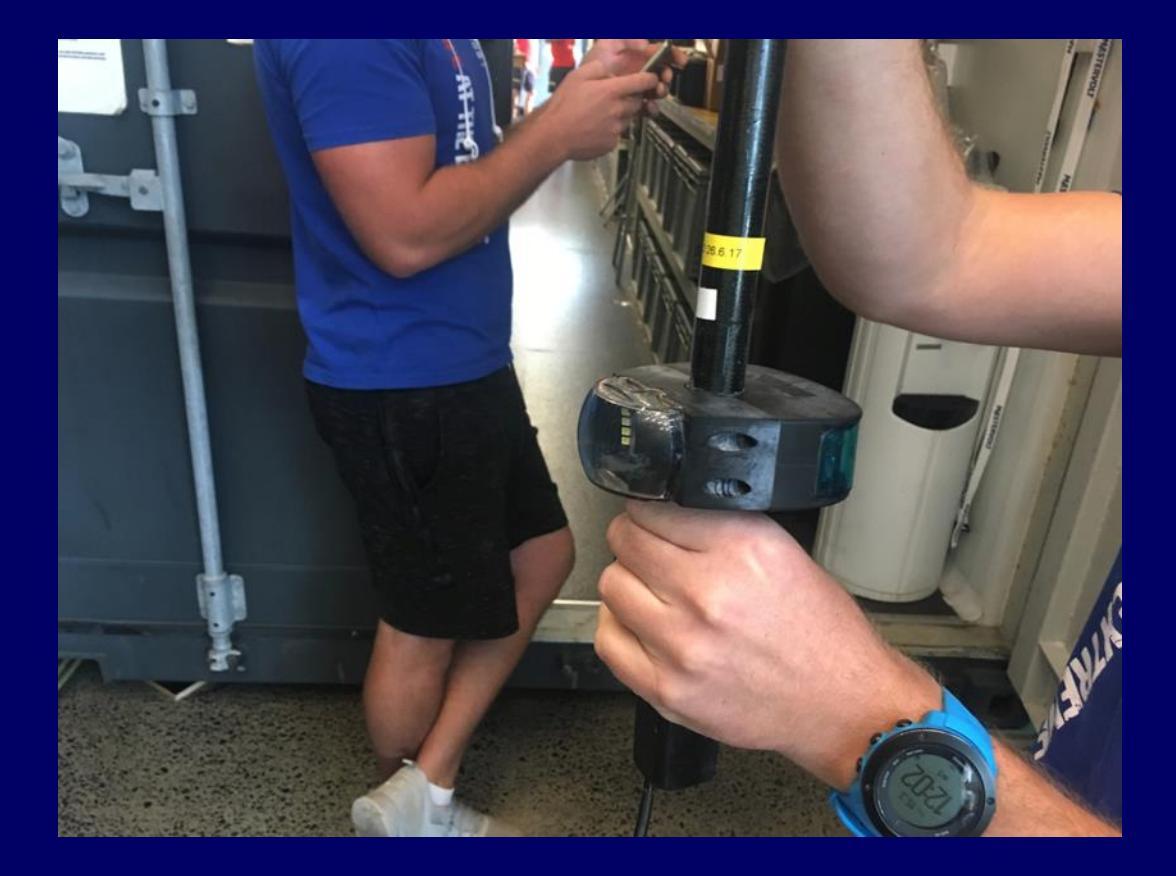
VO 65 solution

Three LED modules, mounted to the carbon wind sensor mast

Not blocked by anything but the Windex and VHF antenna
