What We Can Learn from Sailing Accidents to Benefit Sailors

Sally Lindsay Honey, Chair, Safety at Sea Committee

Sailing Incidents

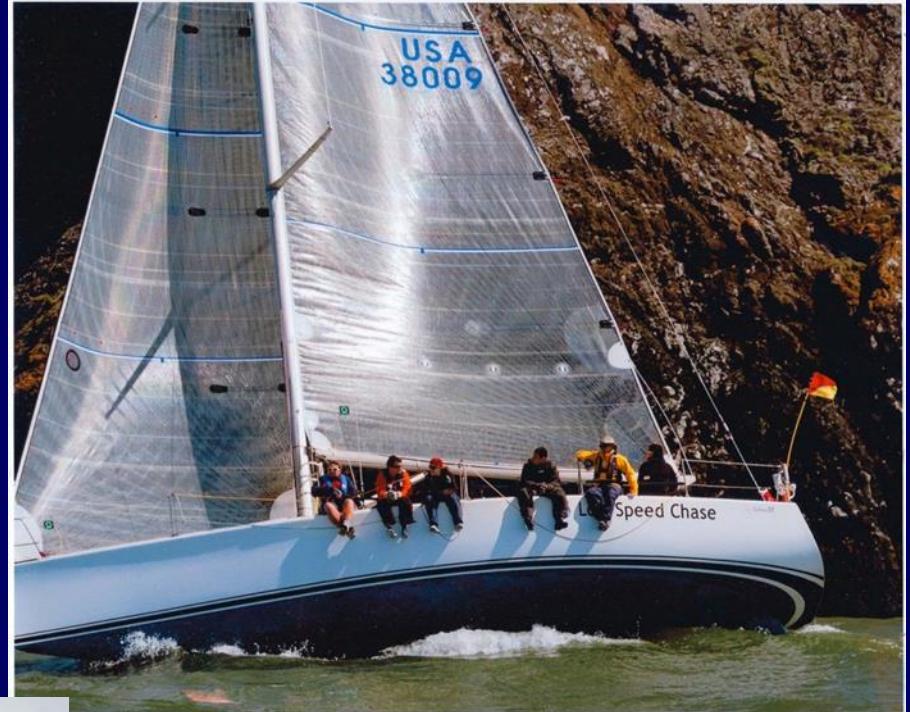
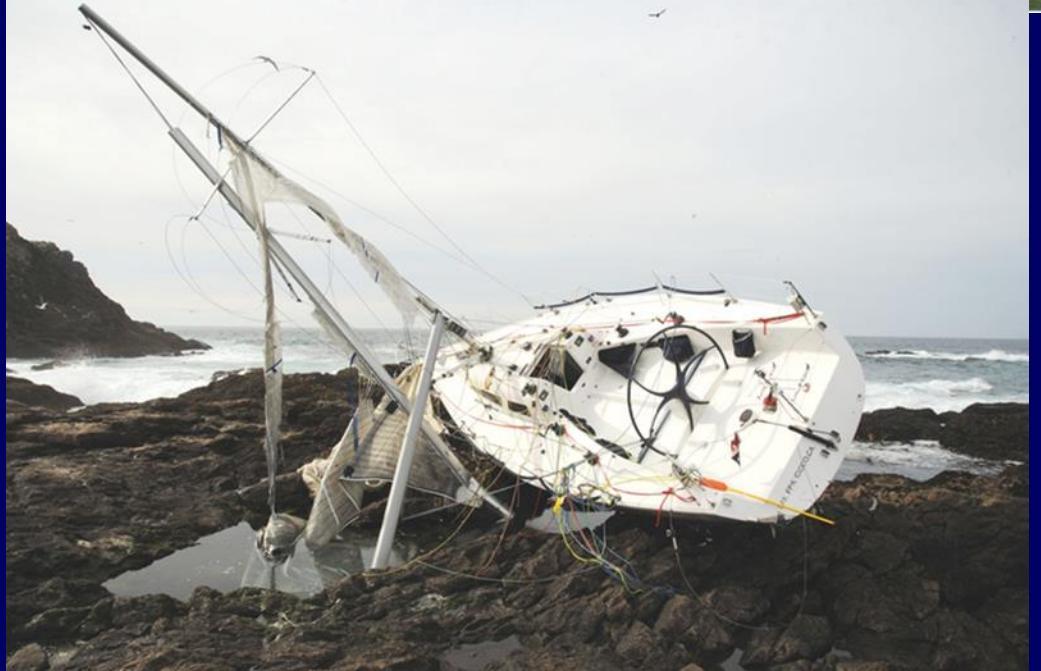
Farallones Race San Francisco April 14, 2012

turned tragic:
Breaking wave
Lee Shore
5 of 8 crew lost

Failure of seamanship in negotiating shoal waters on a lee shore

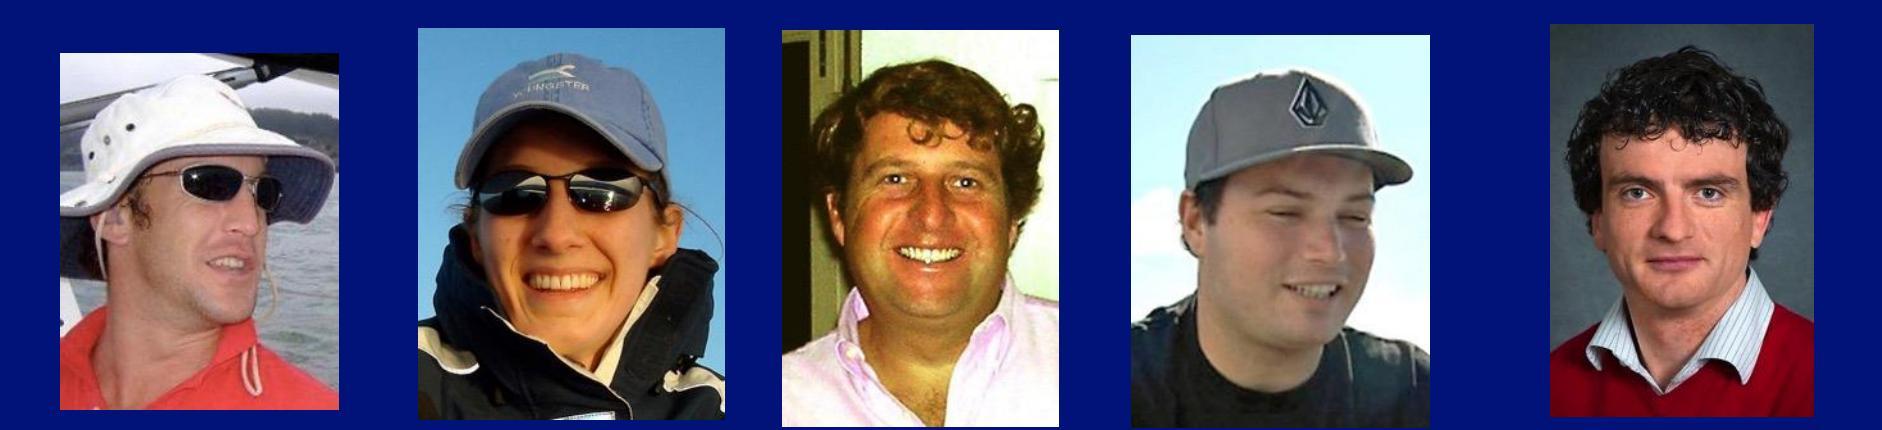
Lost At Sea -

Alan Cahill Alexis Busch Marc Kasanin Jordan Fromm Elmer Morrissey

No tethers: 5 of 7 in the water were lost; one on boat survived. Survivors wore life jackets that met US Sailing 5.0.1 Compromised buoyancy in surf/aerated water

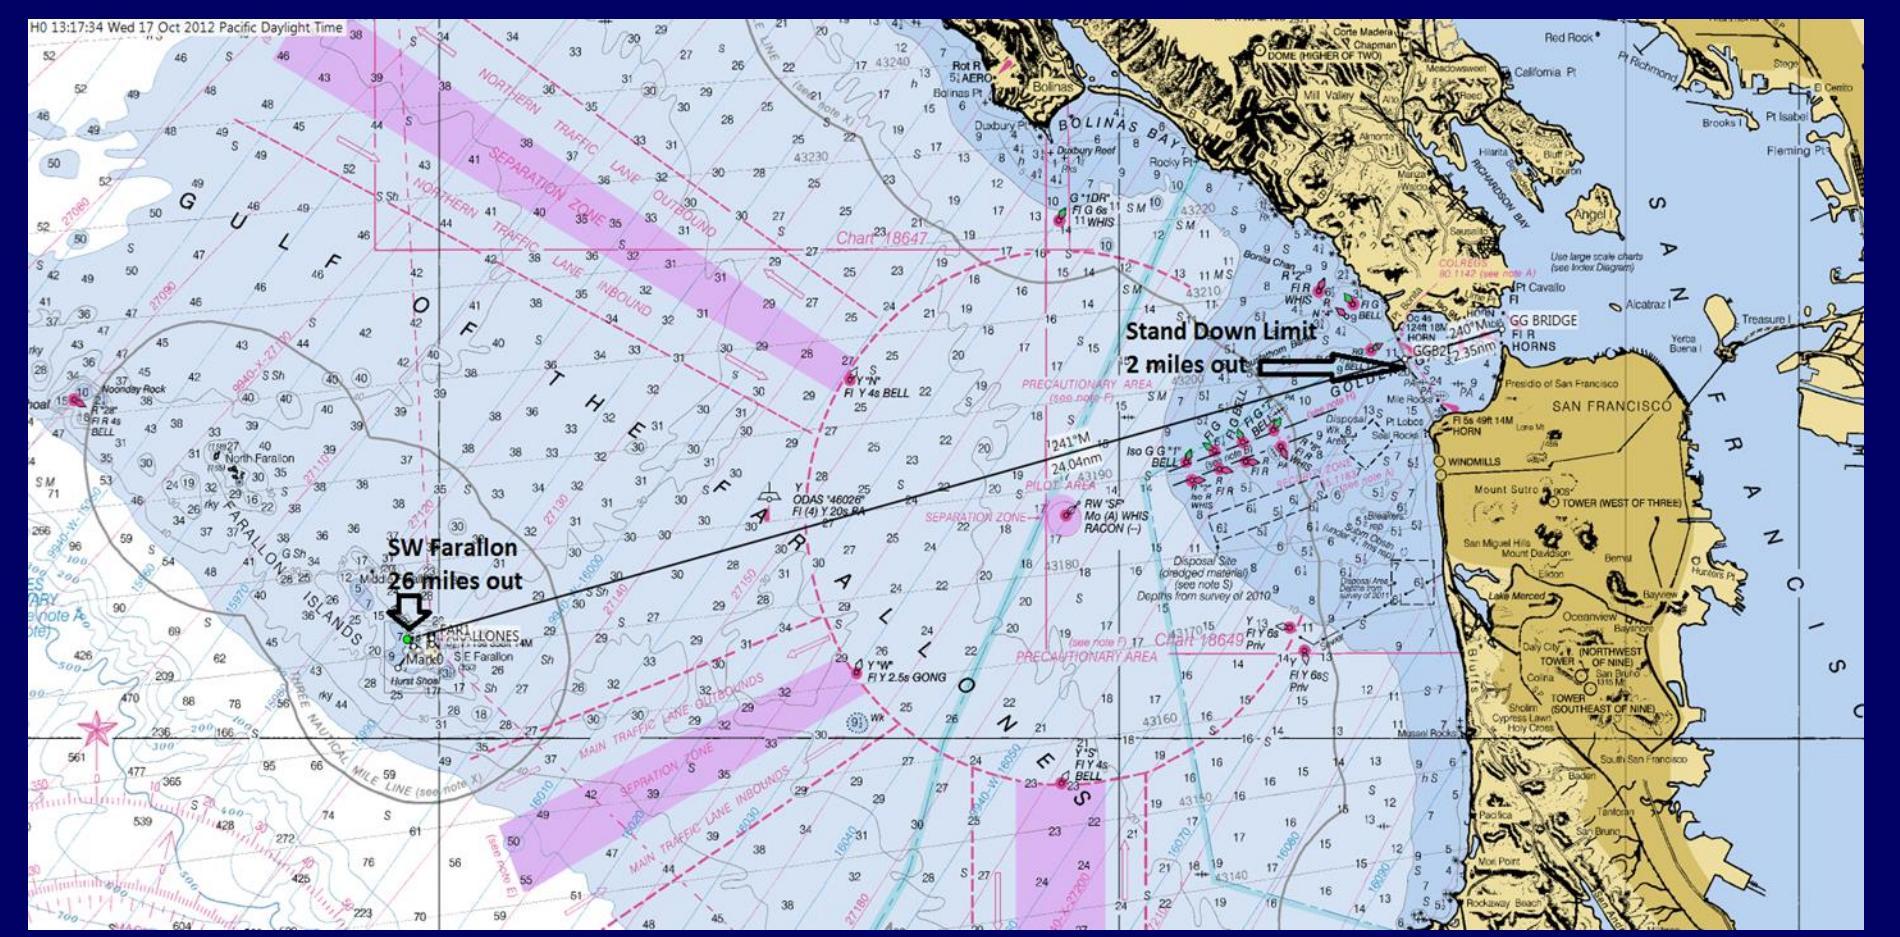
12 days later: USCG Capt. Stowe called for Stand Down in Gulf of the Farallones

Restricts offshore races to line from Mt. Bonita to Land's End "San Francisco offshore sailboat racing organizations need to review racing safety protocols and seek improvement"

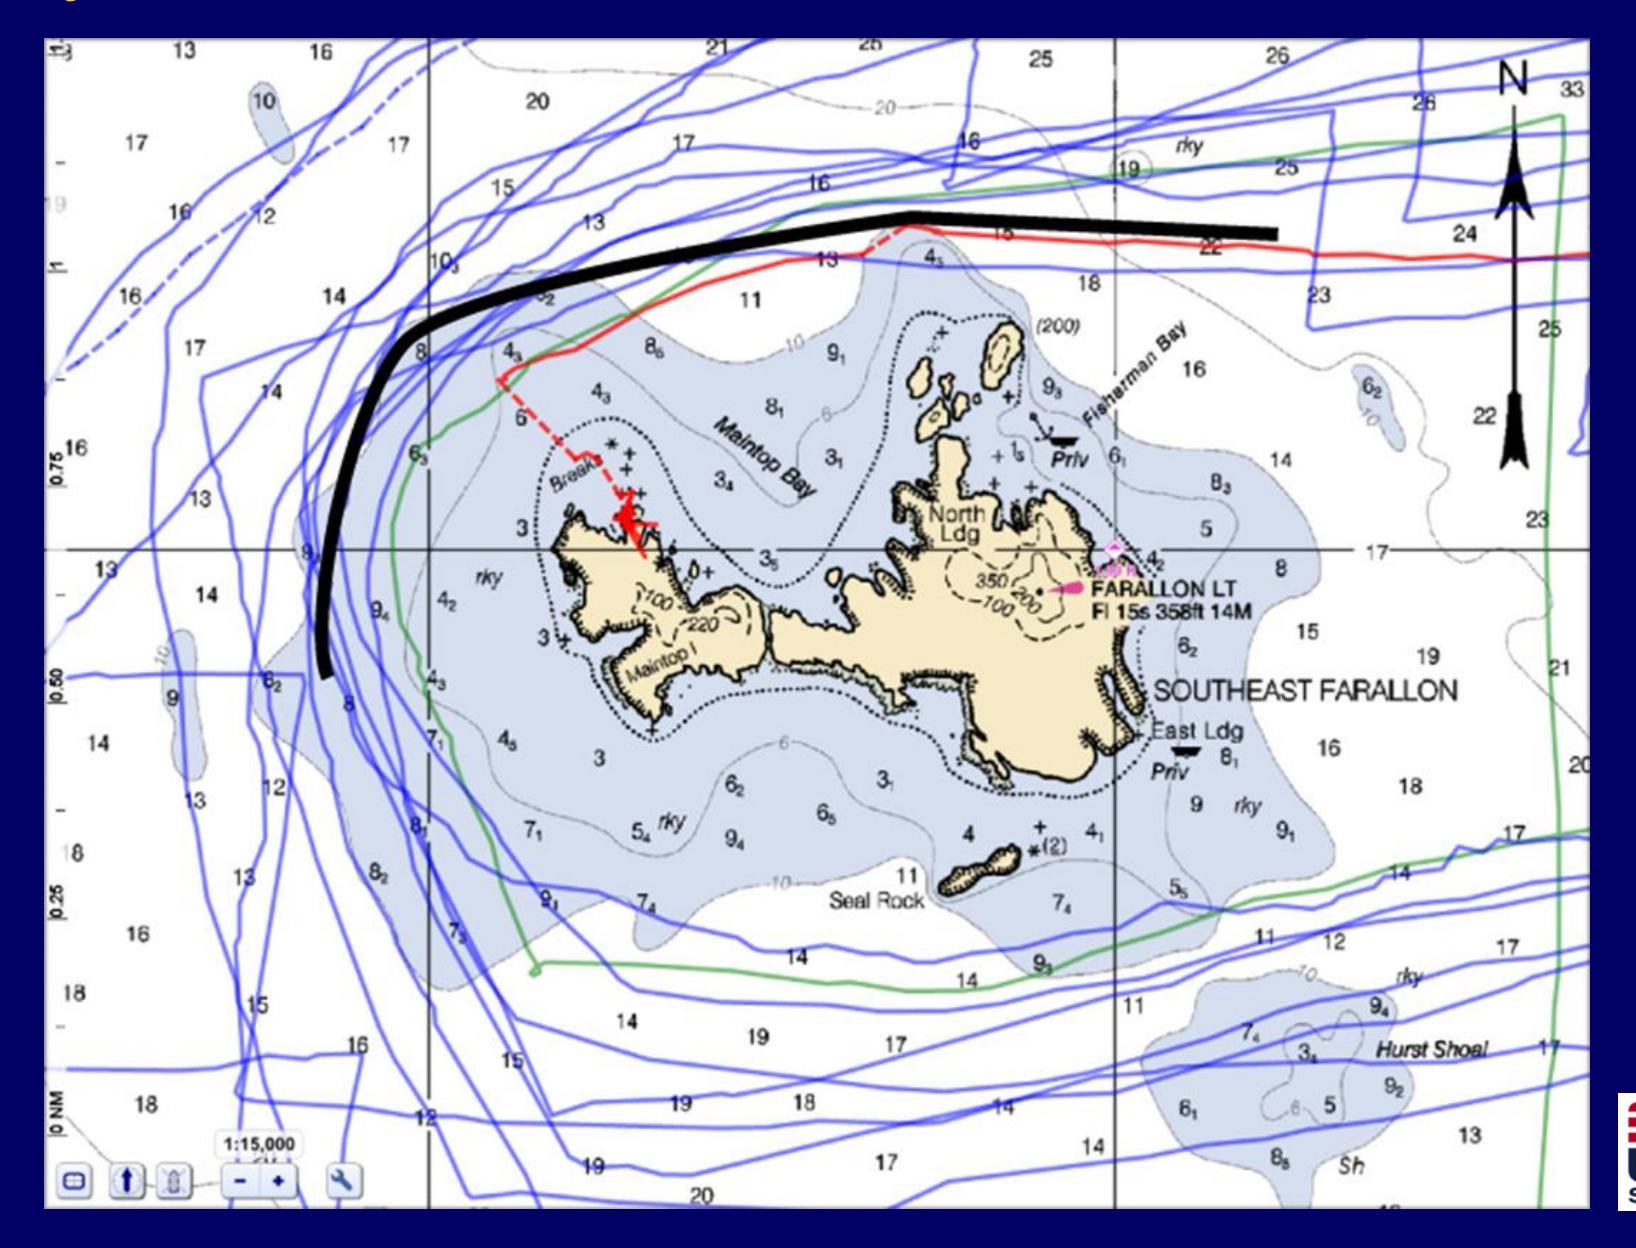
Only Prevention: more conservative course

- 1. Annual Training to improve seamanship, specifically on breaking wave development.
- 2. Require personal flotation to meet USS prescription 5.0.1, training in jackline rigging and use, spot inspections to ensure MER compliance.
- 3. Improve VHF communication infrastructure
- 4. Improve race management accountability of boats and crew on the race course.

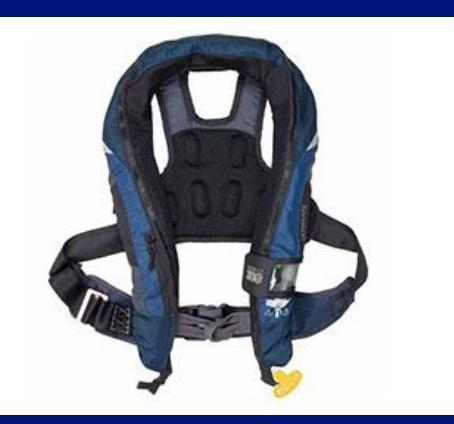
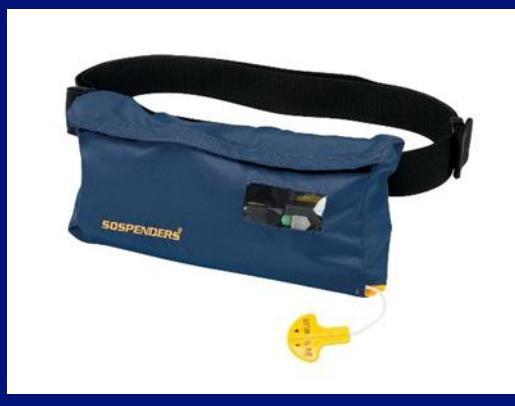
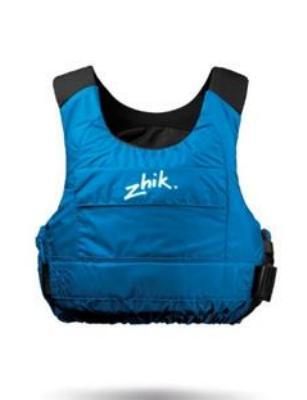
Inadequate personal safety gear for offshore conditions

- Racers required to "have" lifejackets to meet US SAILING 5.0.1, but only wear "adequate" flotation
- Category 2 requirements not met by two crew
- Of crew in water, those wearing 5.0.1 life jackets survived, none had thigh straps
- Jacklines deployed per requirement, not used

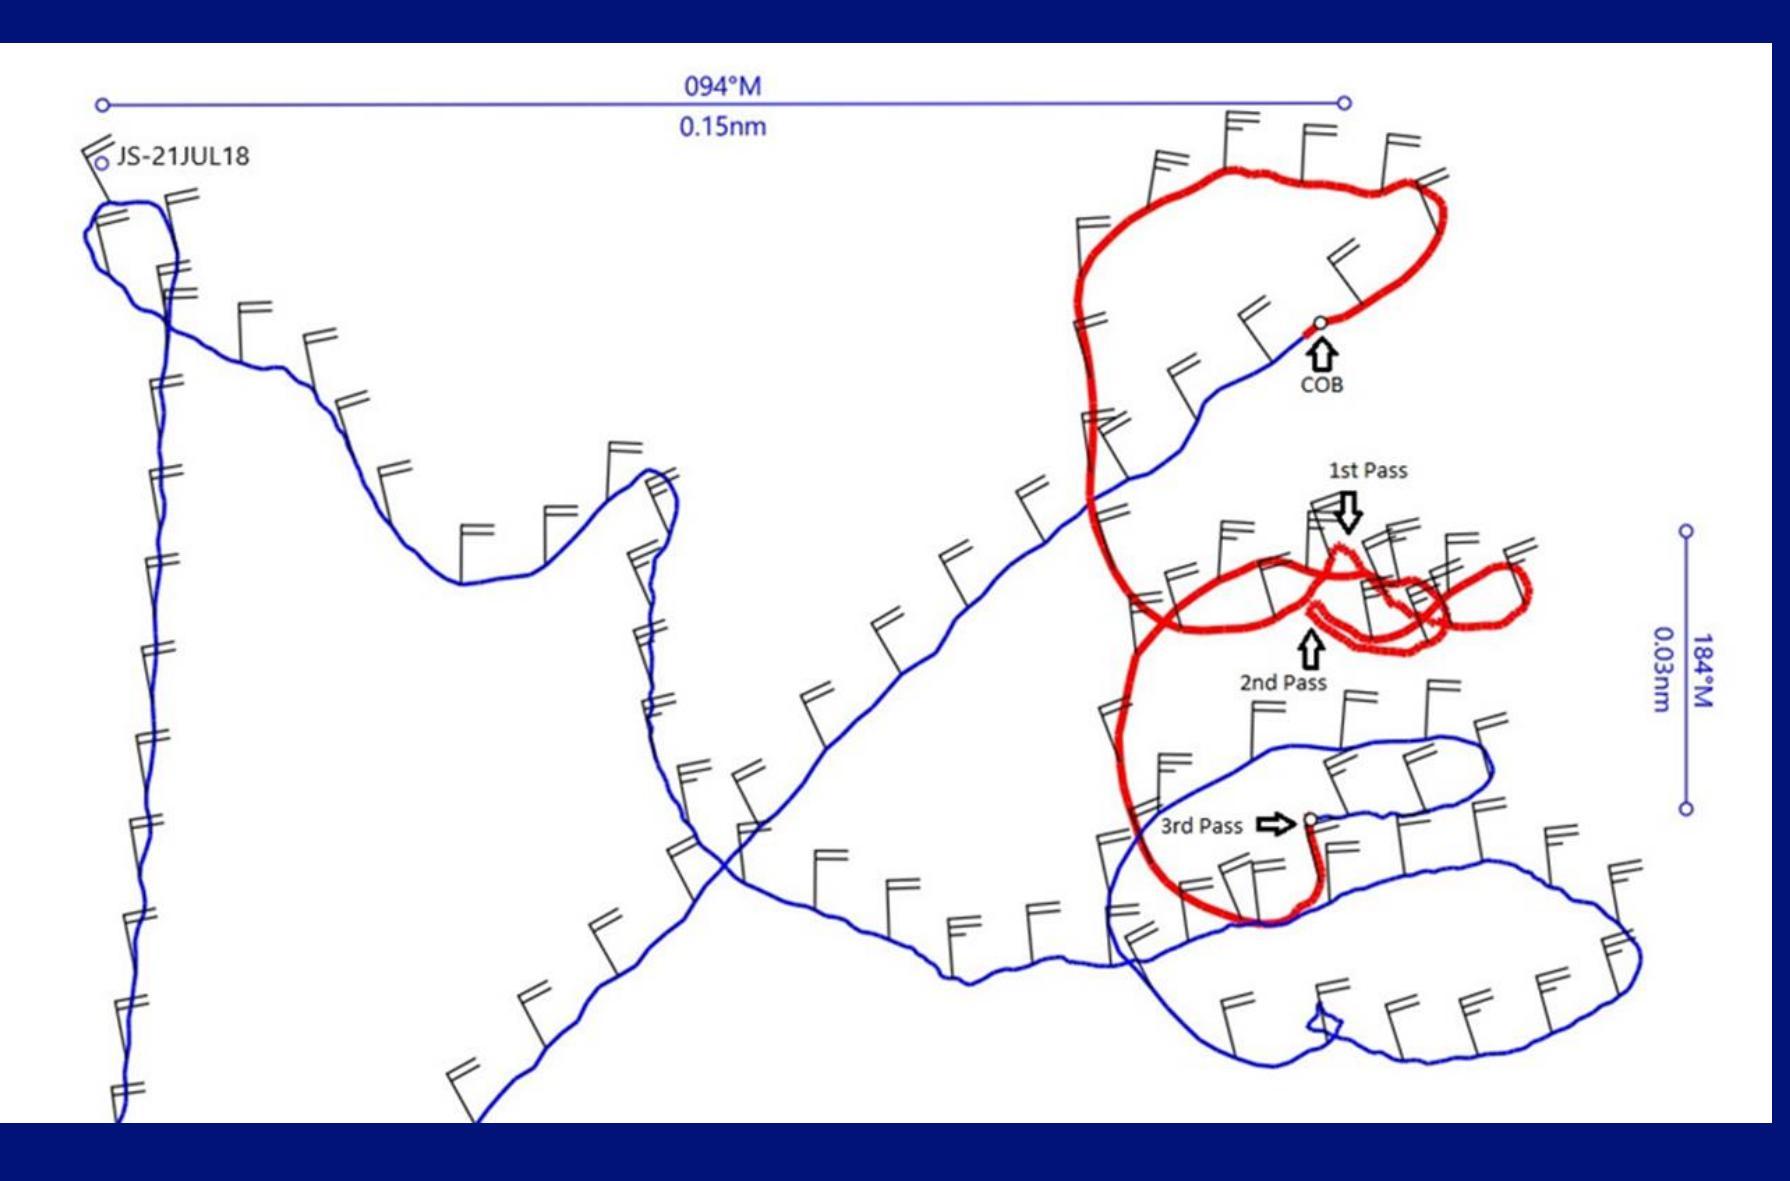
Imedi recovery attempts

Jon Santarelli was fit, conscious, swimming. Why did he drown?

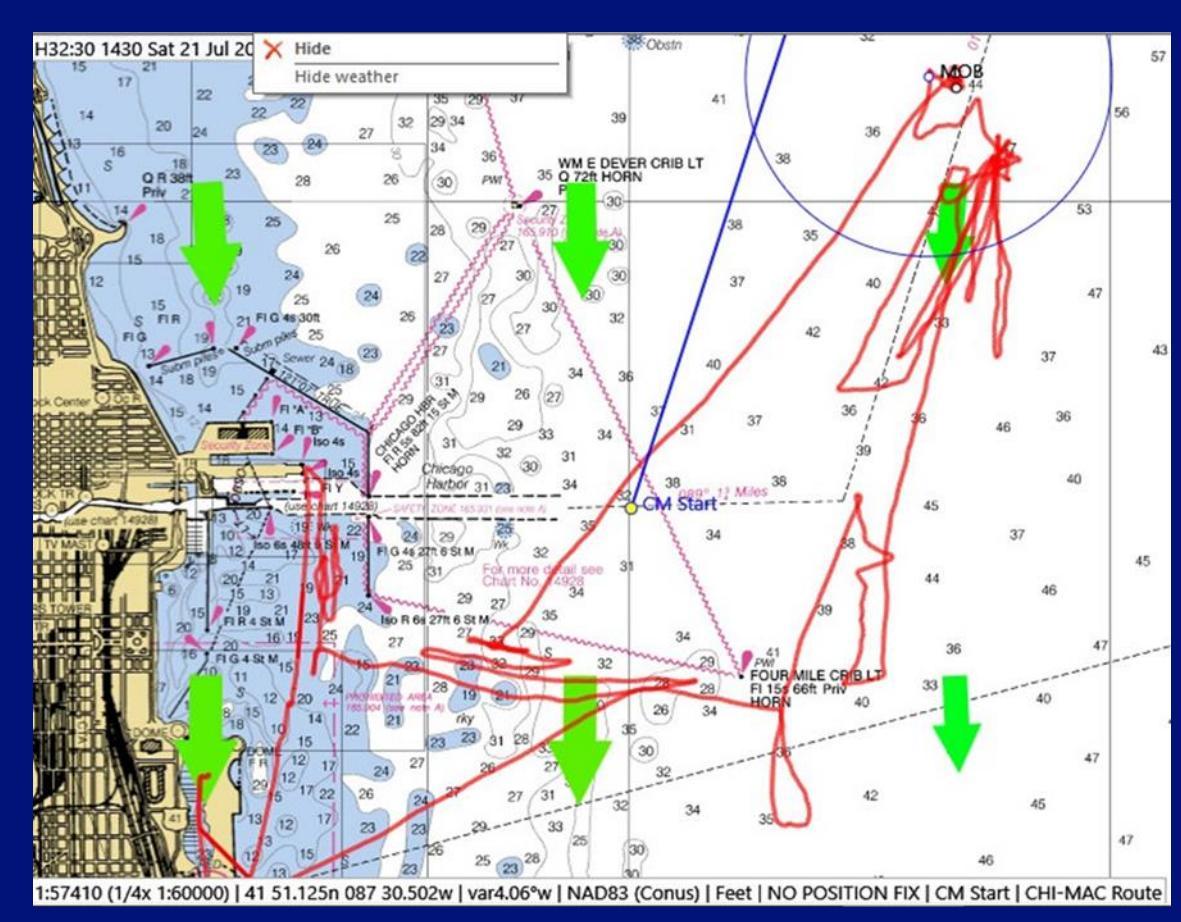
- 3. Command Structure: poorly defined
- 4. Unused Equipment:LifeSling,MOM

- 1. Comprehensive Dock Talk: command structure, crew roles, procedures
- 2. Establish/communicate COB procedures
- 3. Safety gear: Inspect, fit, instruct prior to use
- 4. Practice in expected conditions
- 5. As PIW: act immediately
- 6. Enhanced training needed for inflatable lifejackets

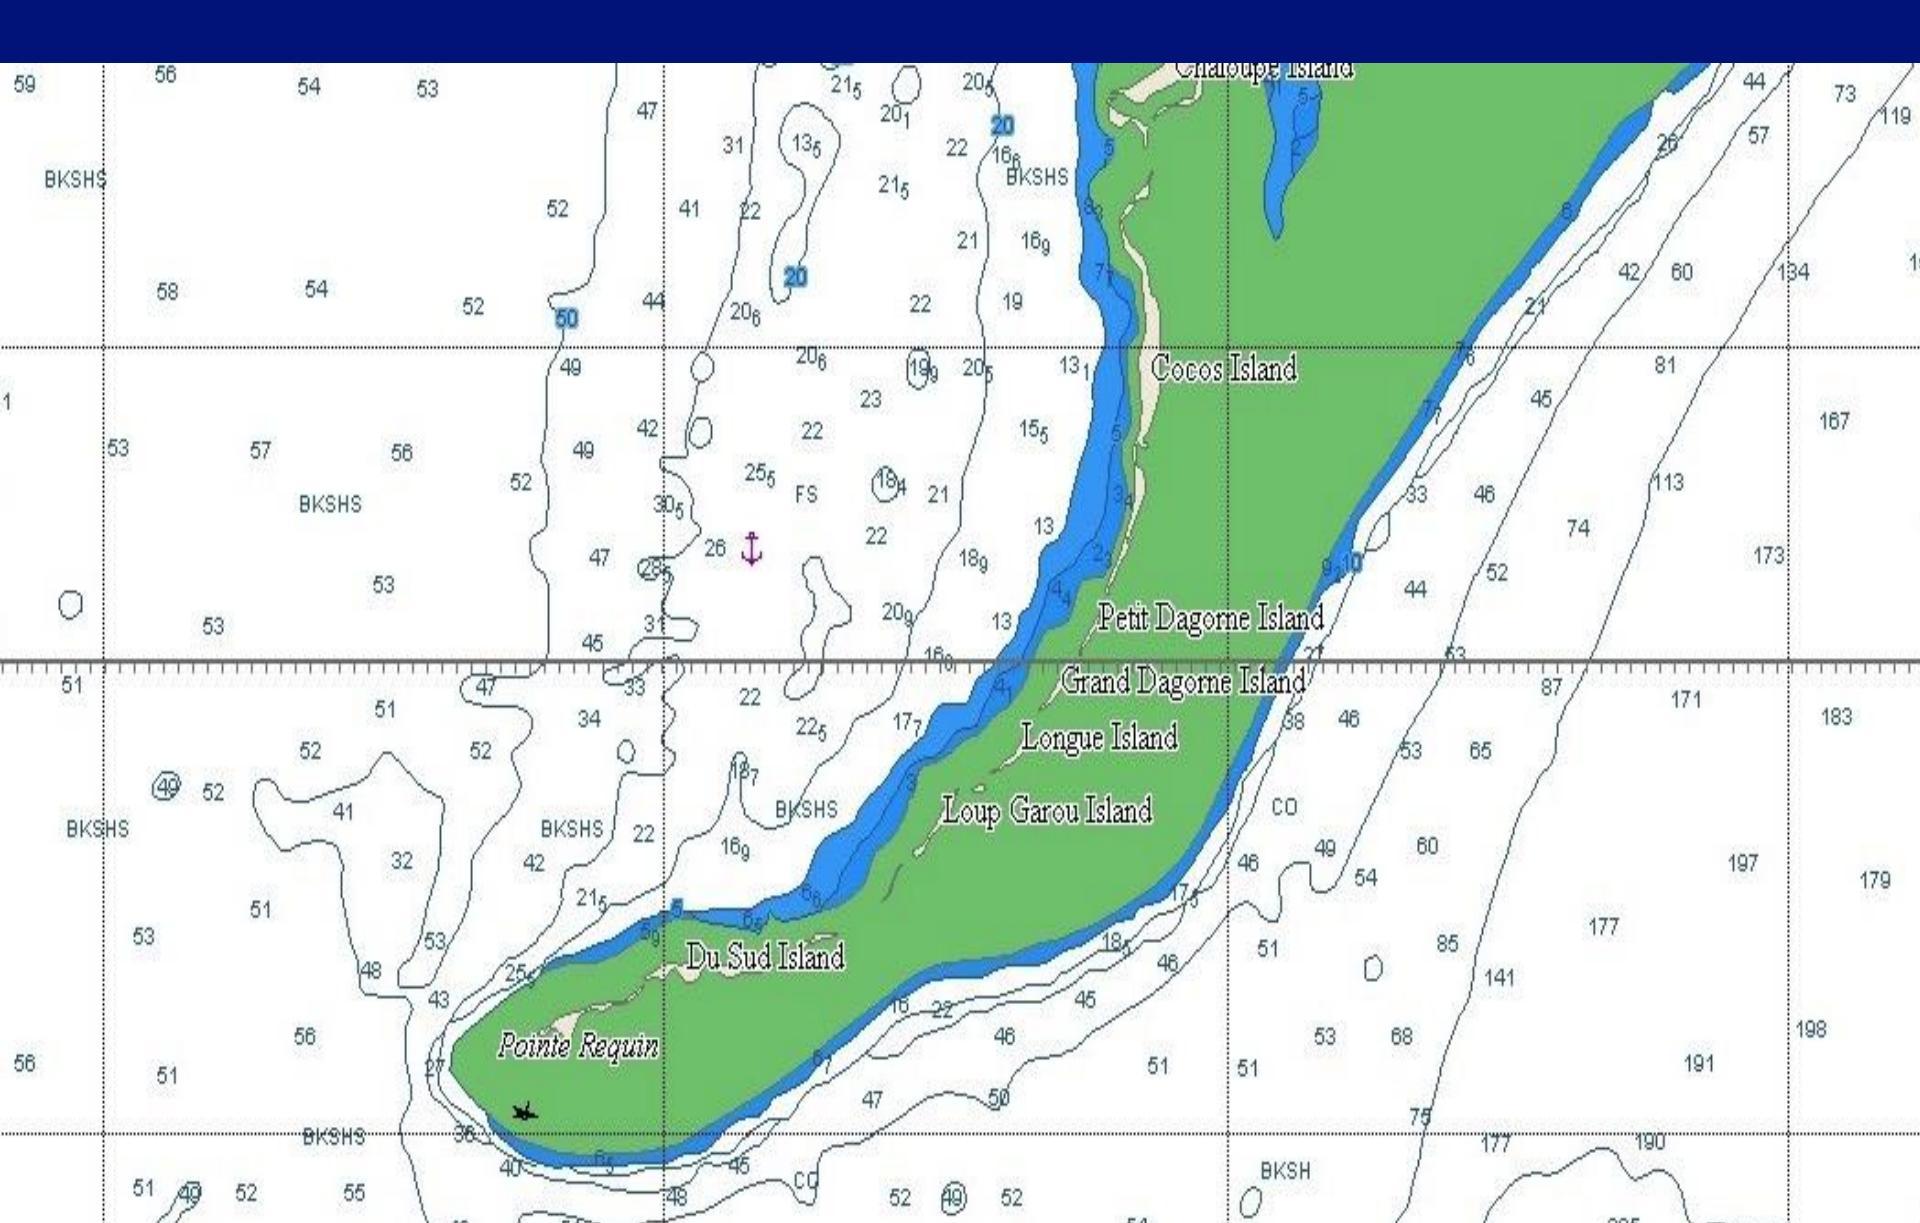
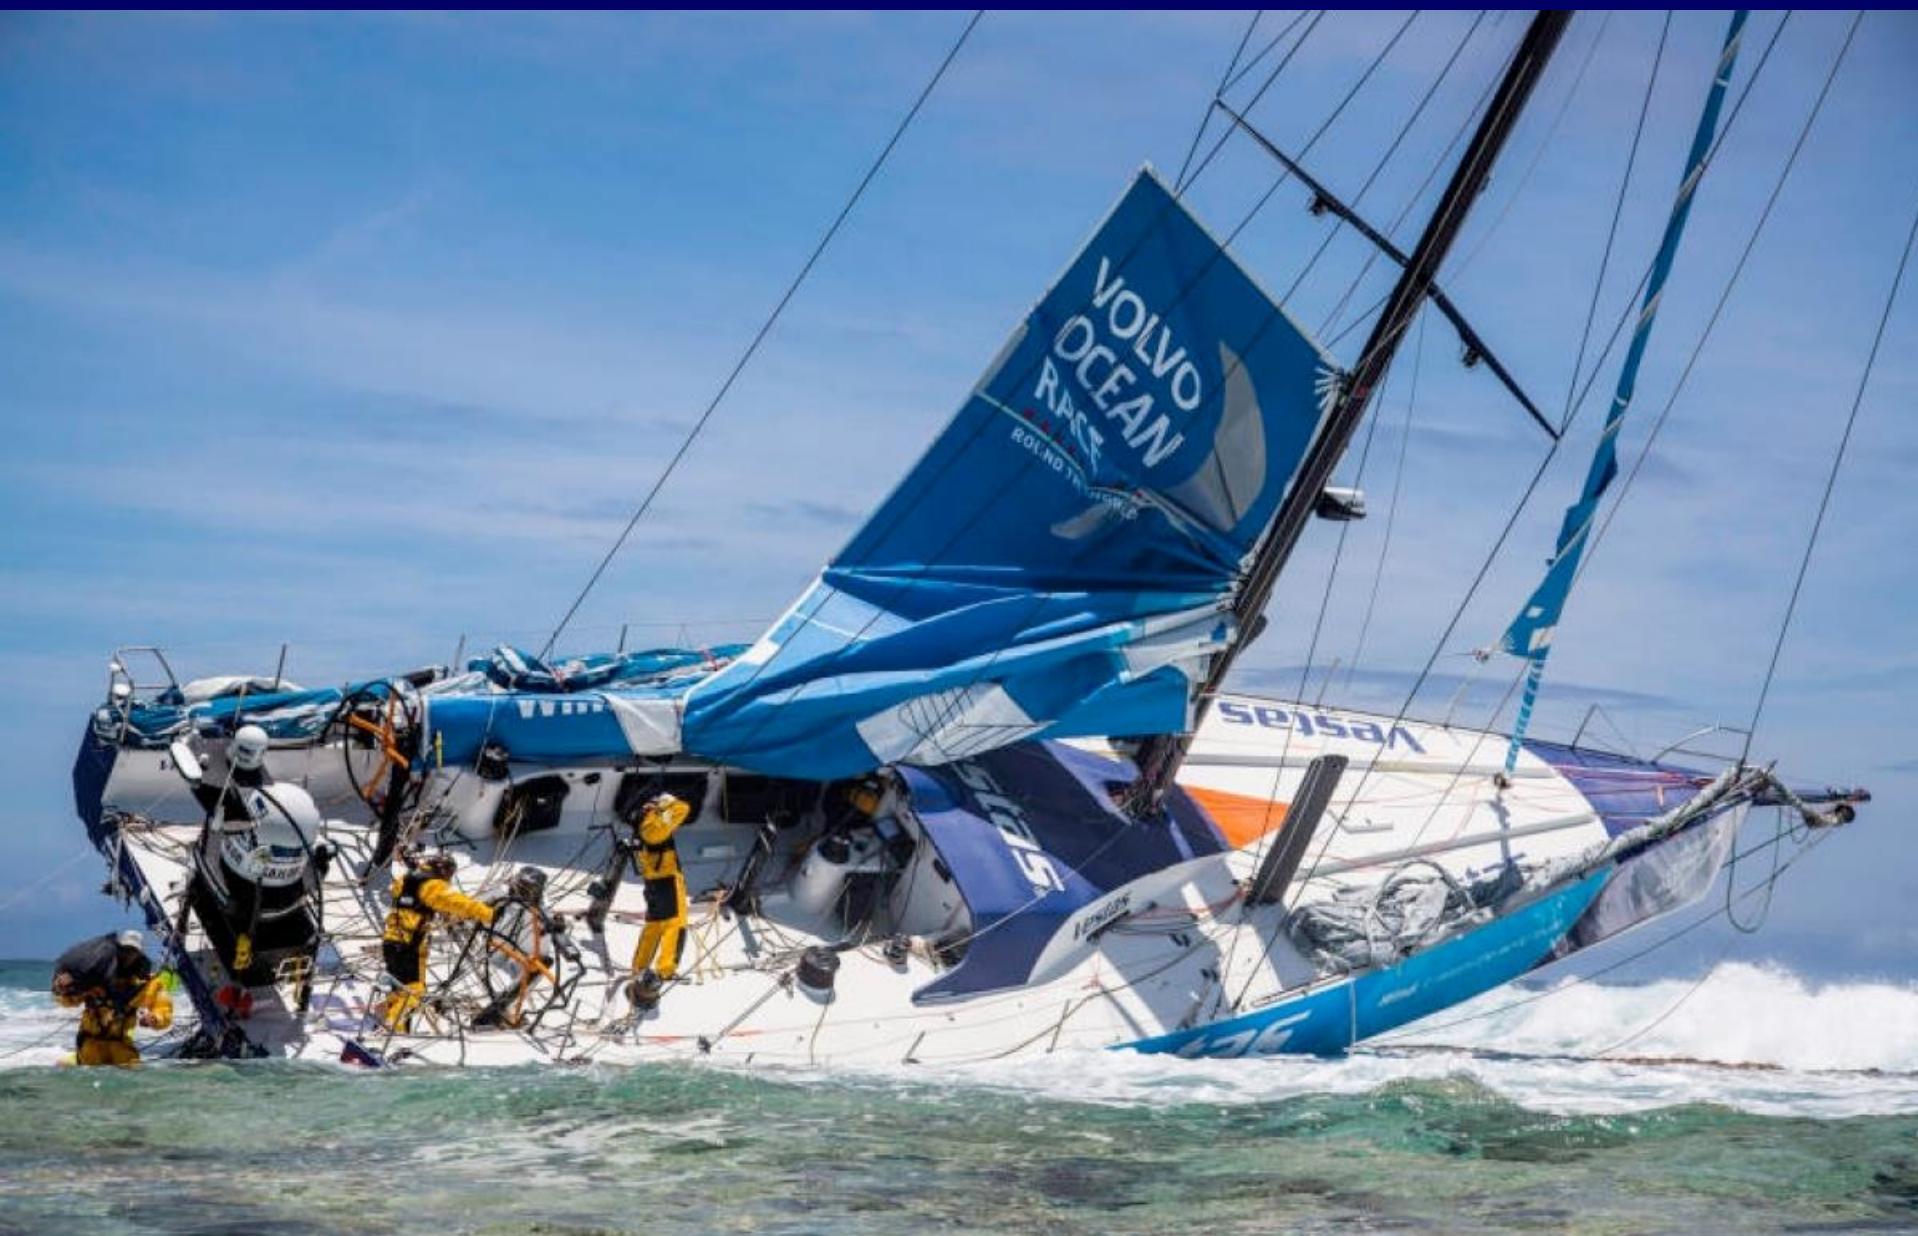
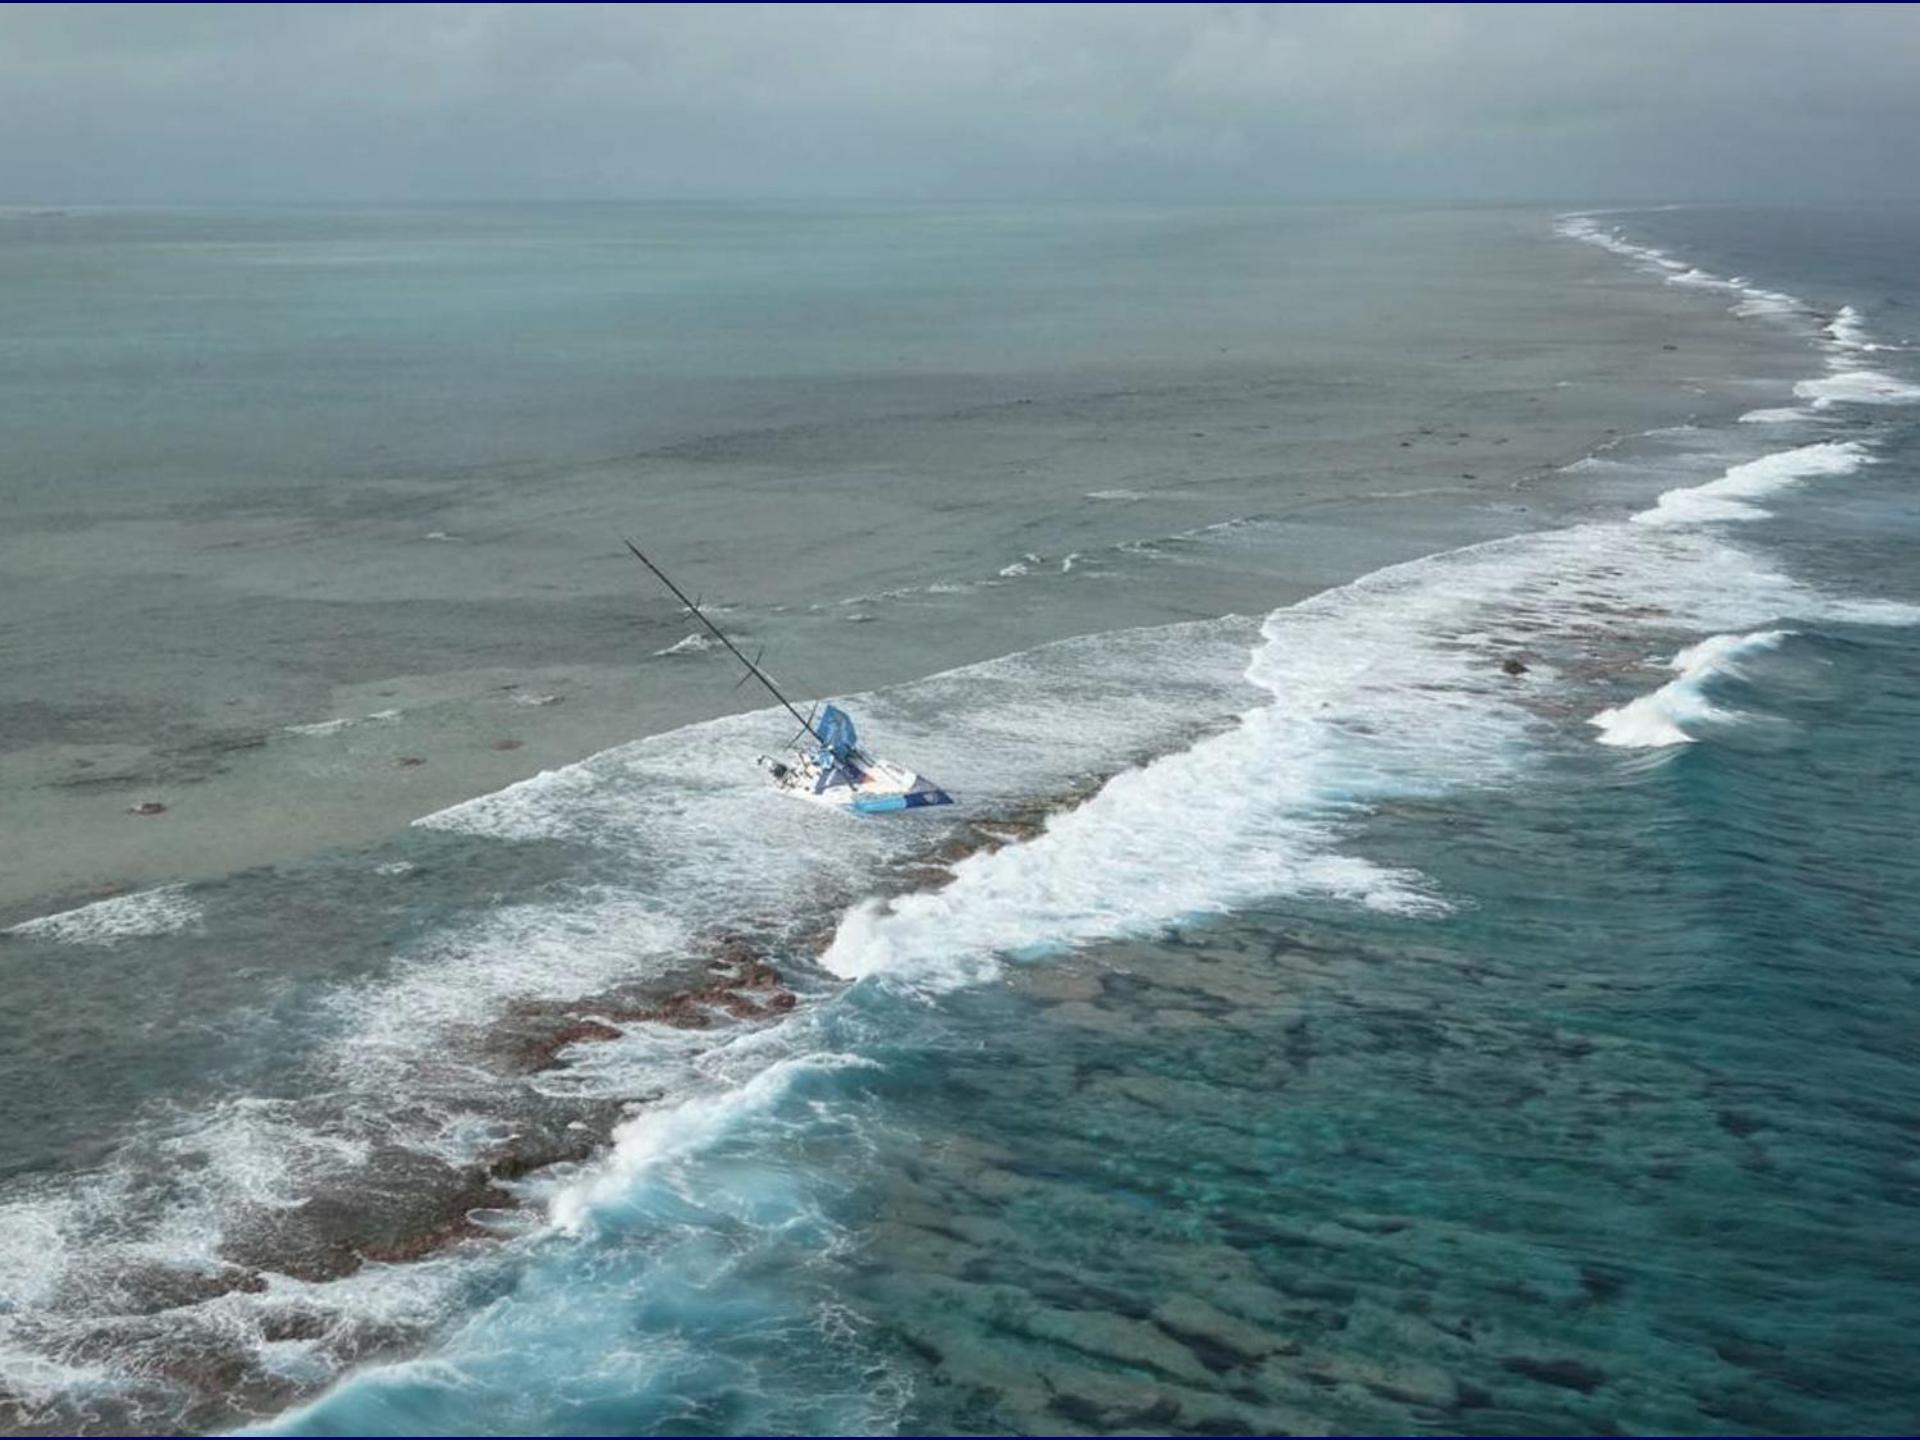
C-MAP Chart, zoomed in

- Exclusion zone changed ~ 36h before race start
- Navigator and skipper did not zoom in on C-Map charts; were completely unaware of the danger
- Conditions they encountered matched what they had imagined and warned the crew about
- Did not use radar or depth sounder because there was no perceived need.
- C-Map charts were not effective at alerting the crew to the danger of the reef

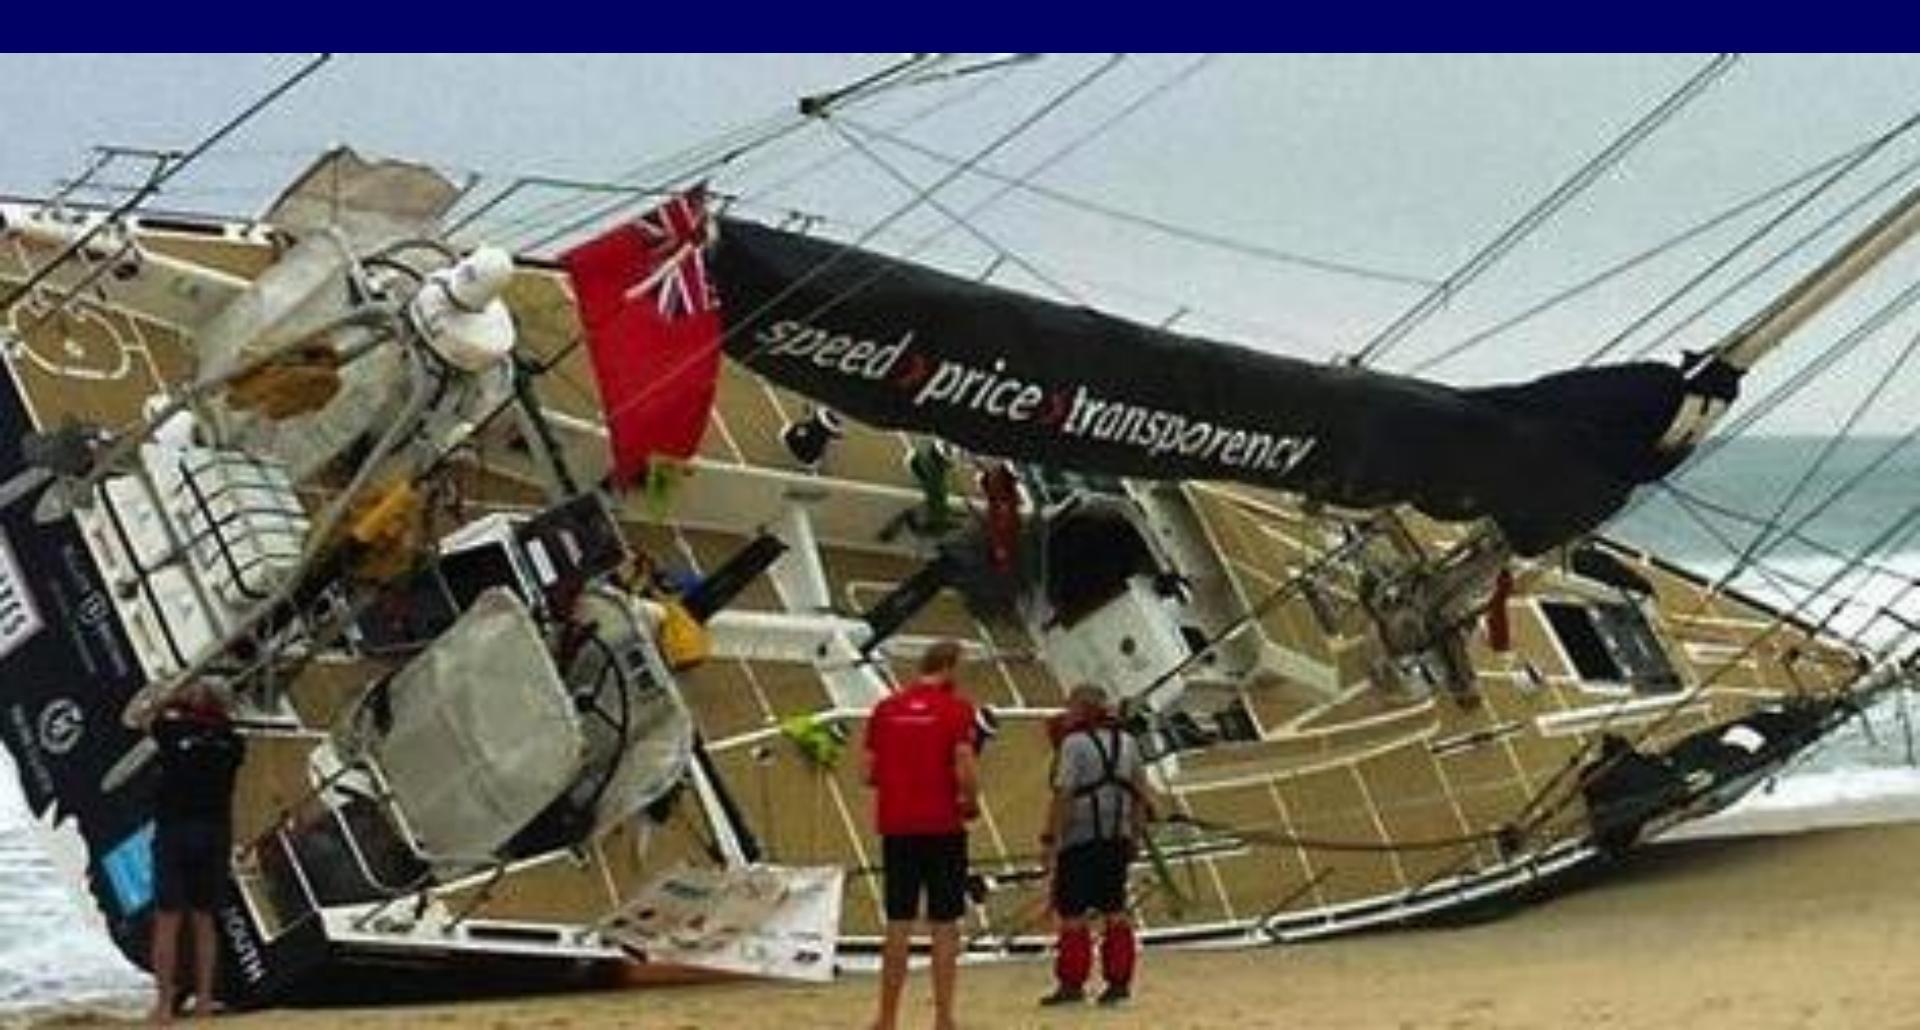
Aground in Brazil during 2015-2016 Race

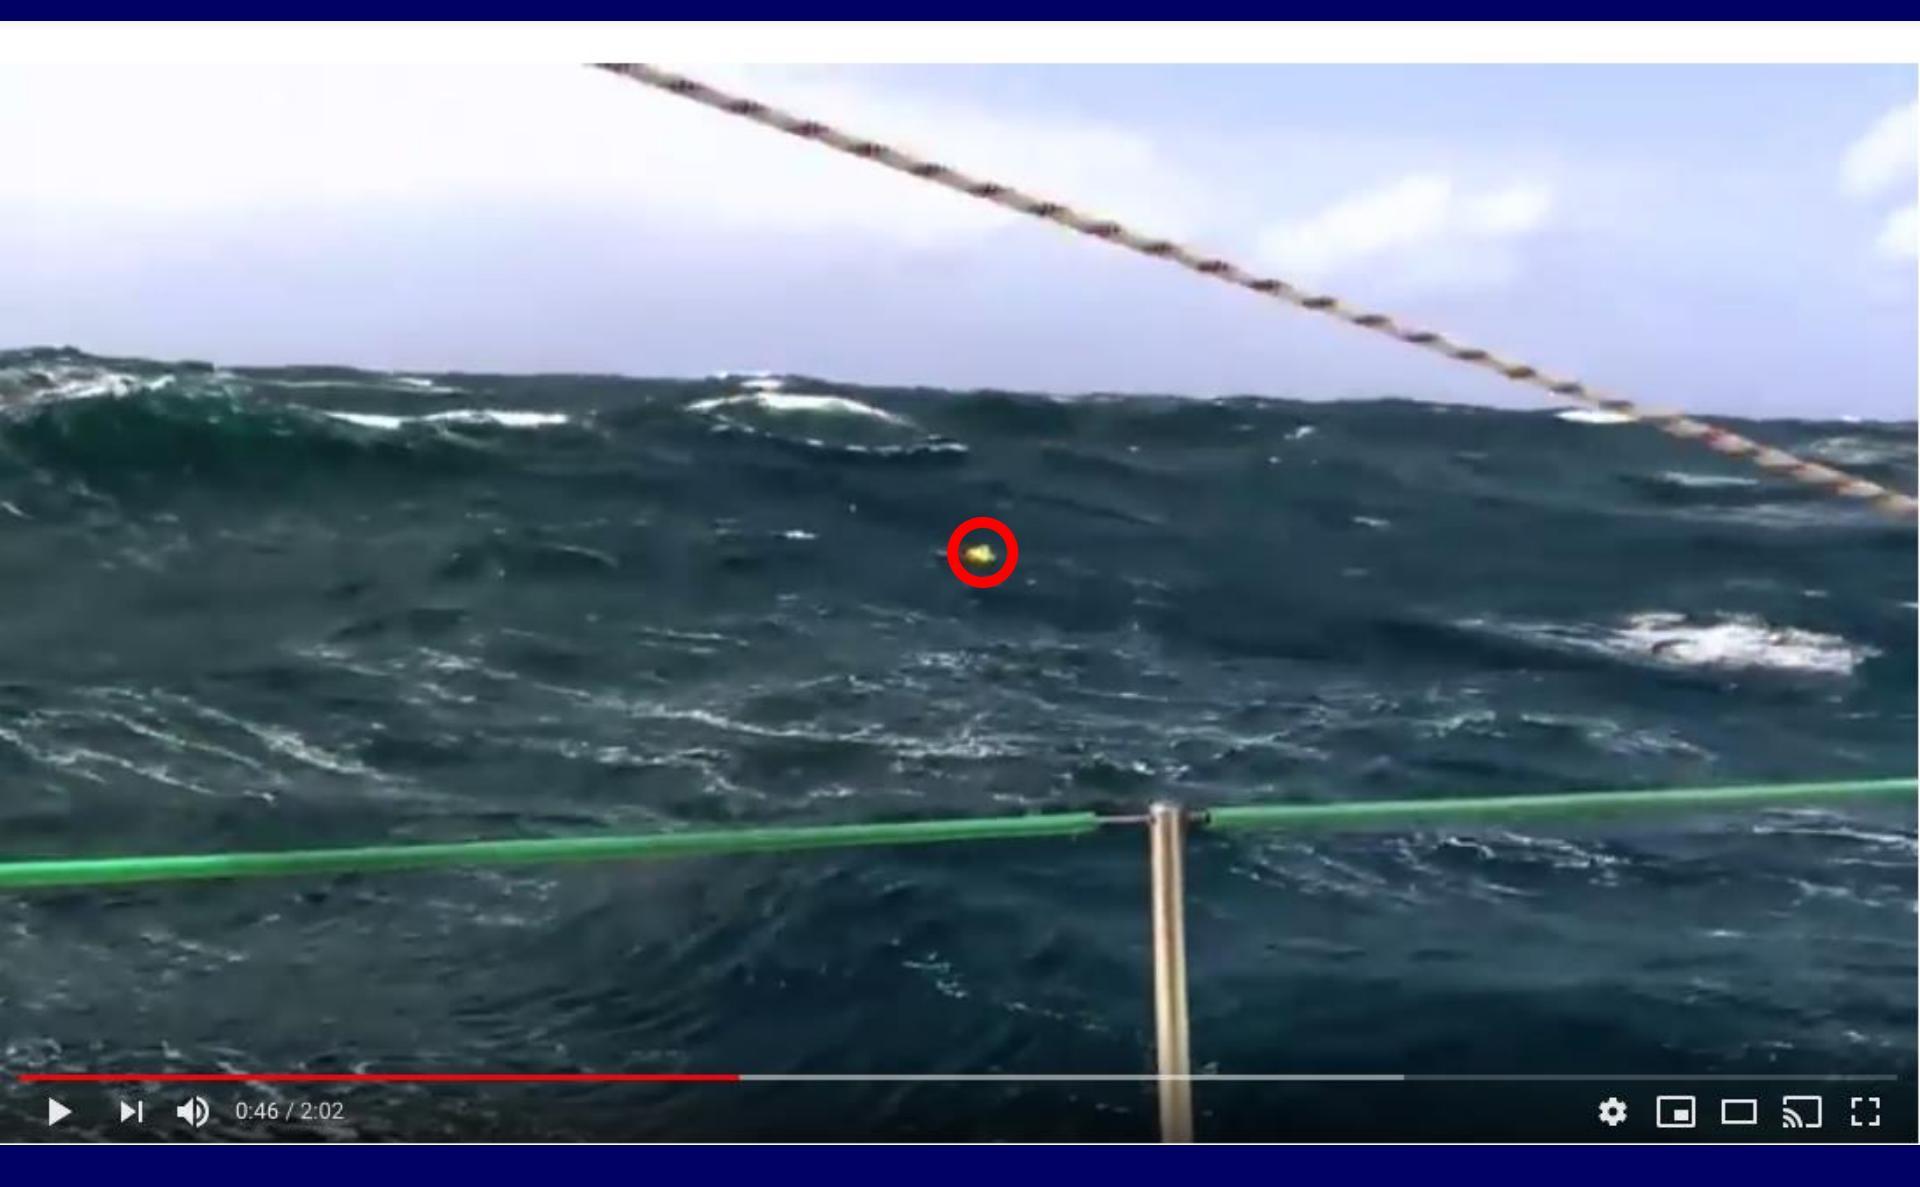
Derry~Londonderry~Doire MOB 3/31/2014

23:43 UTC Man Overboard, initiated MOB procedure
00:55 UTC Crewmember sighted
01:13 UTC Crewmember recovered

90 minutes in the water. Crew made full recovery.
