What We Can Learn from Sailing Accidents to Benefit Sailors

Sally Lindsay Honey, Chair, Safety at Sea Committee

Sailing Incidents

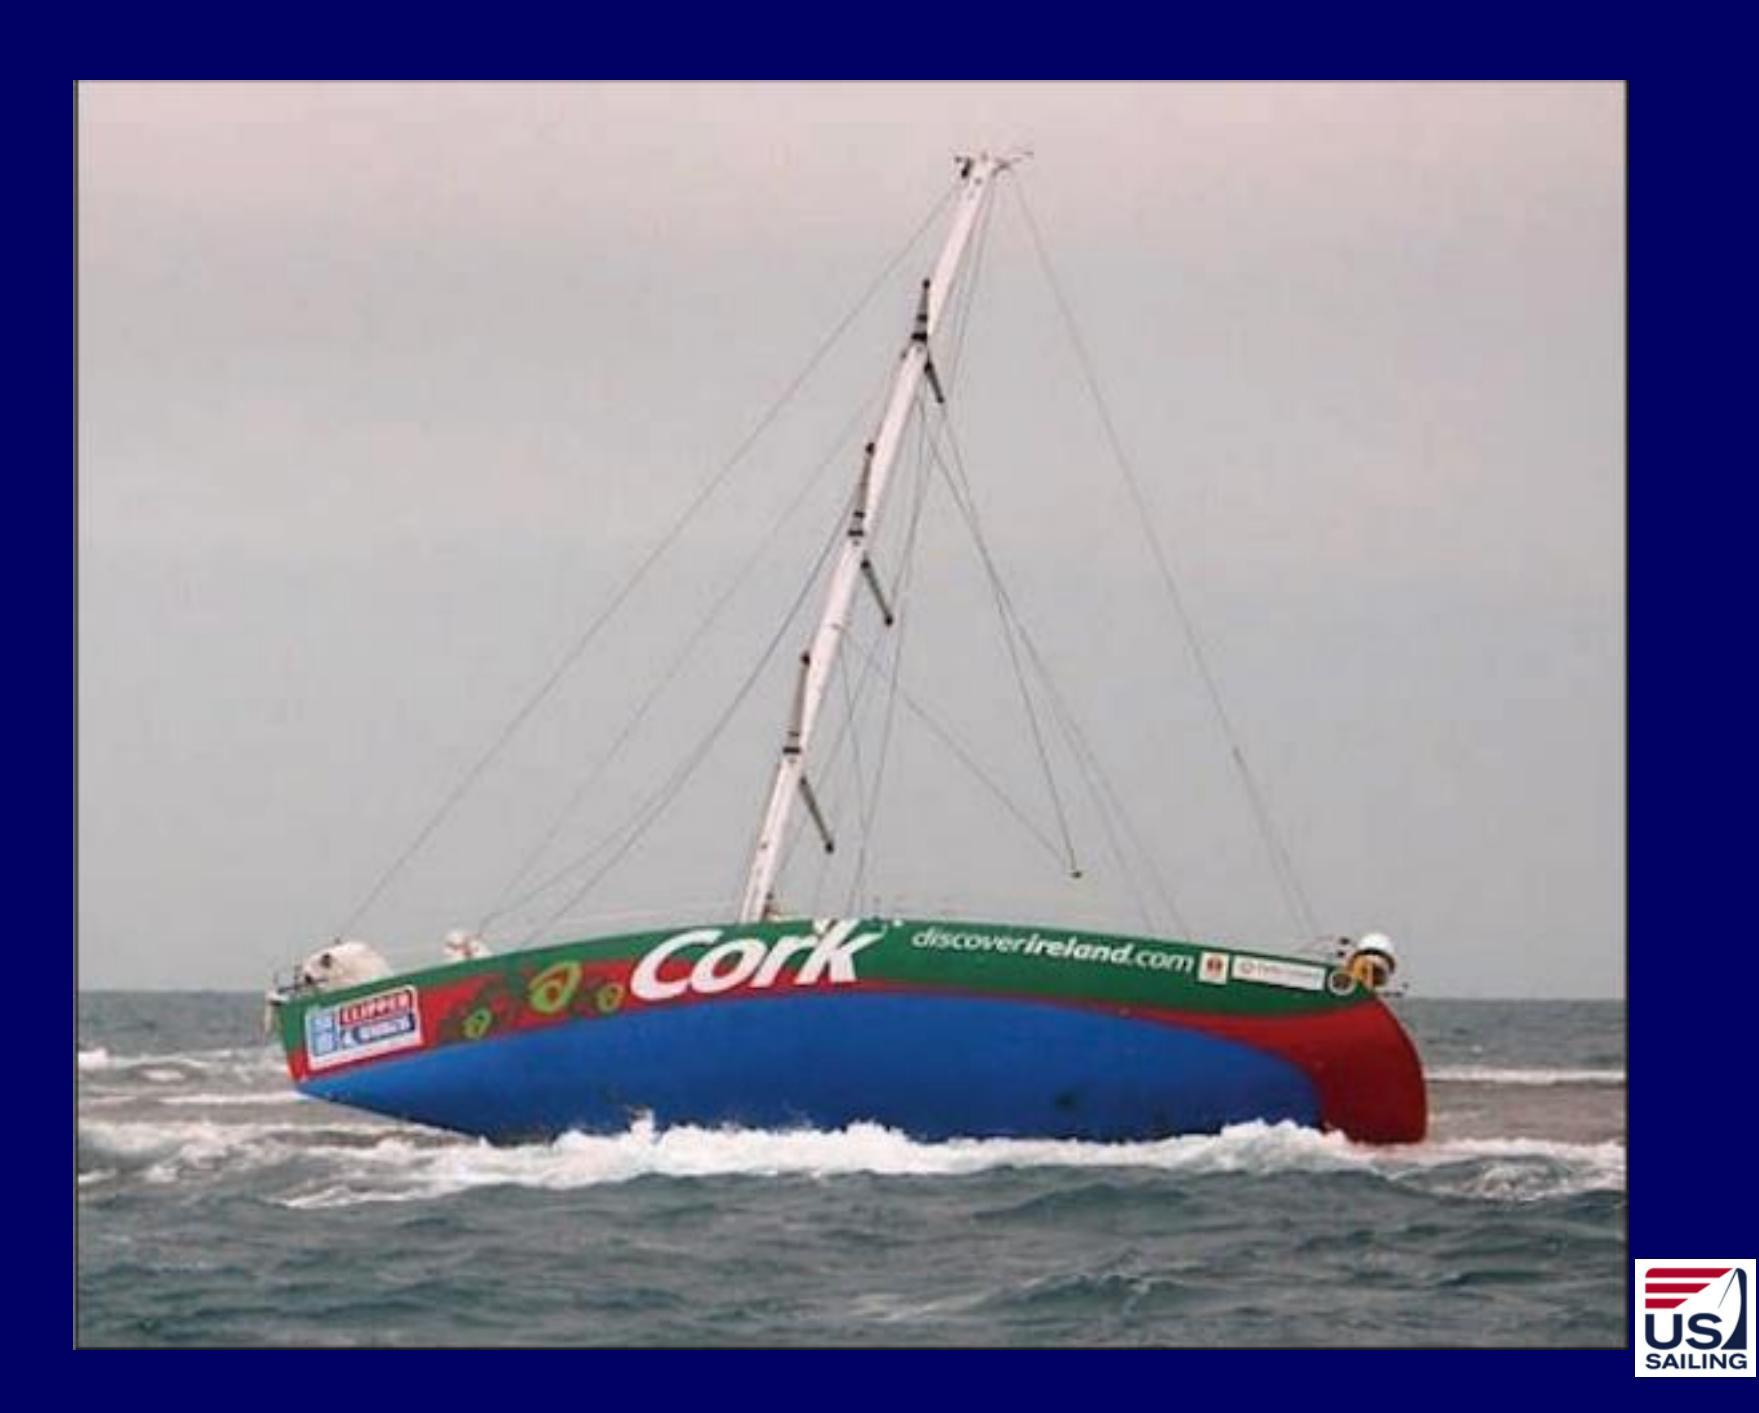
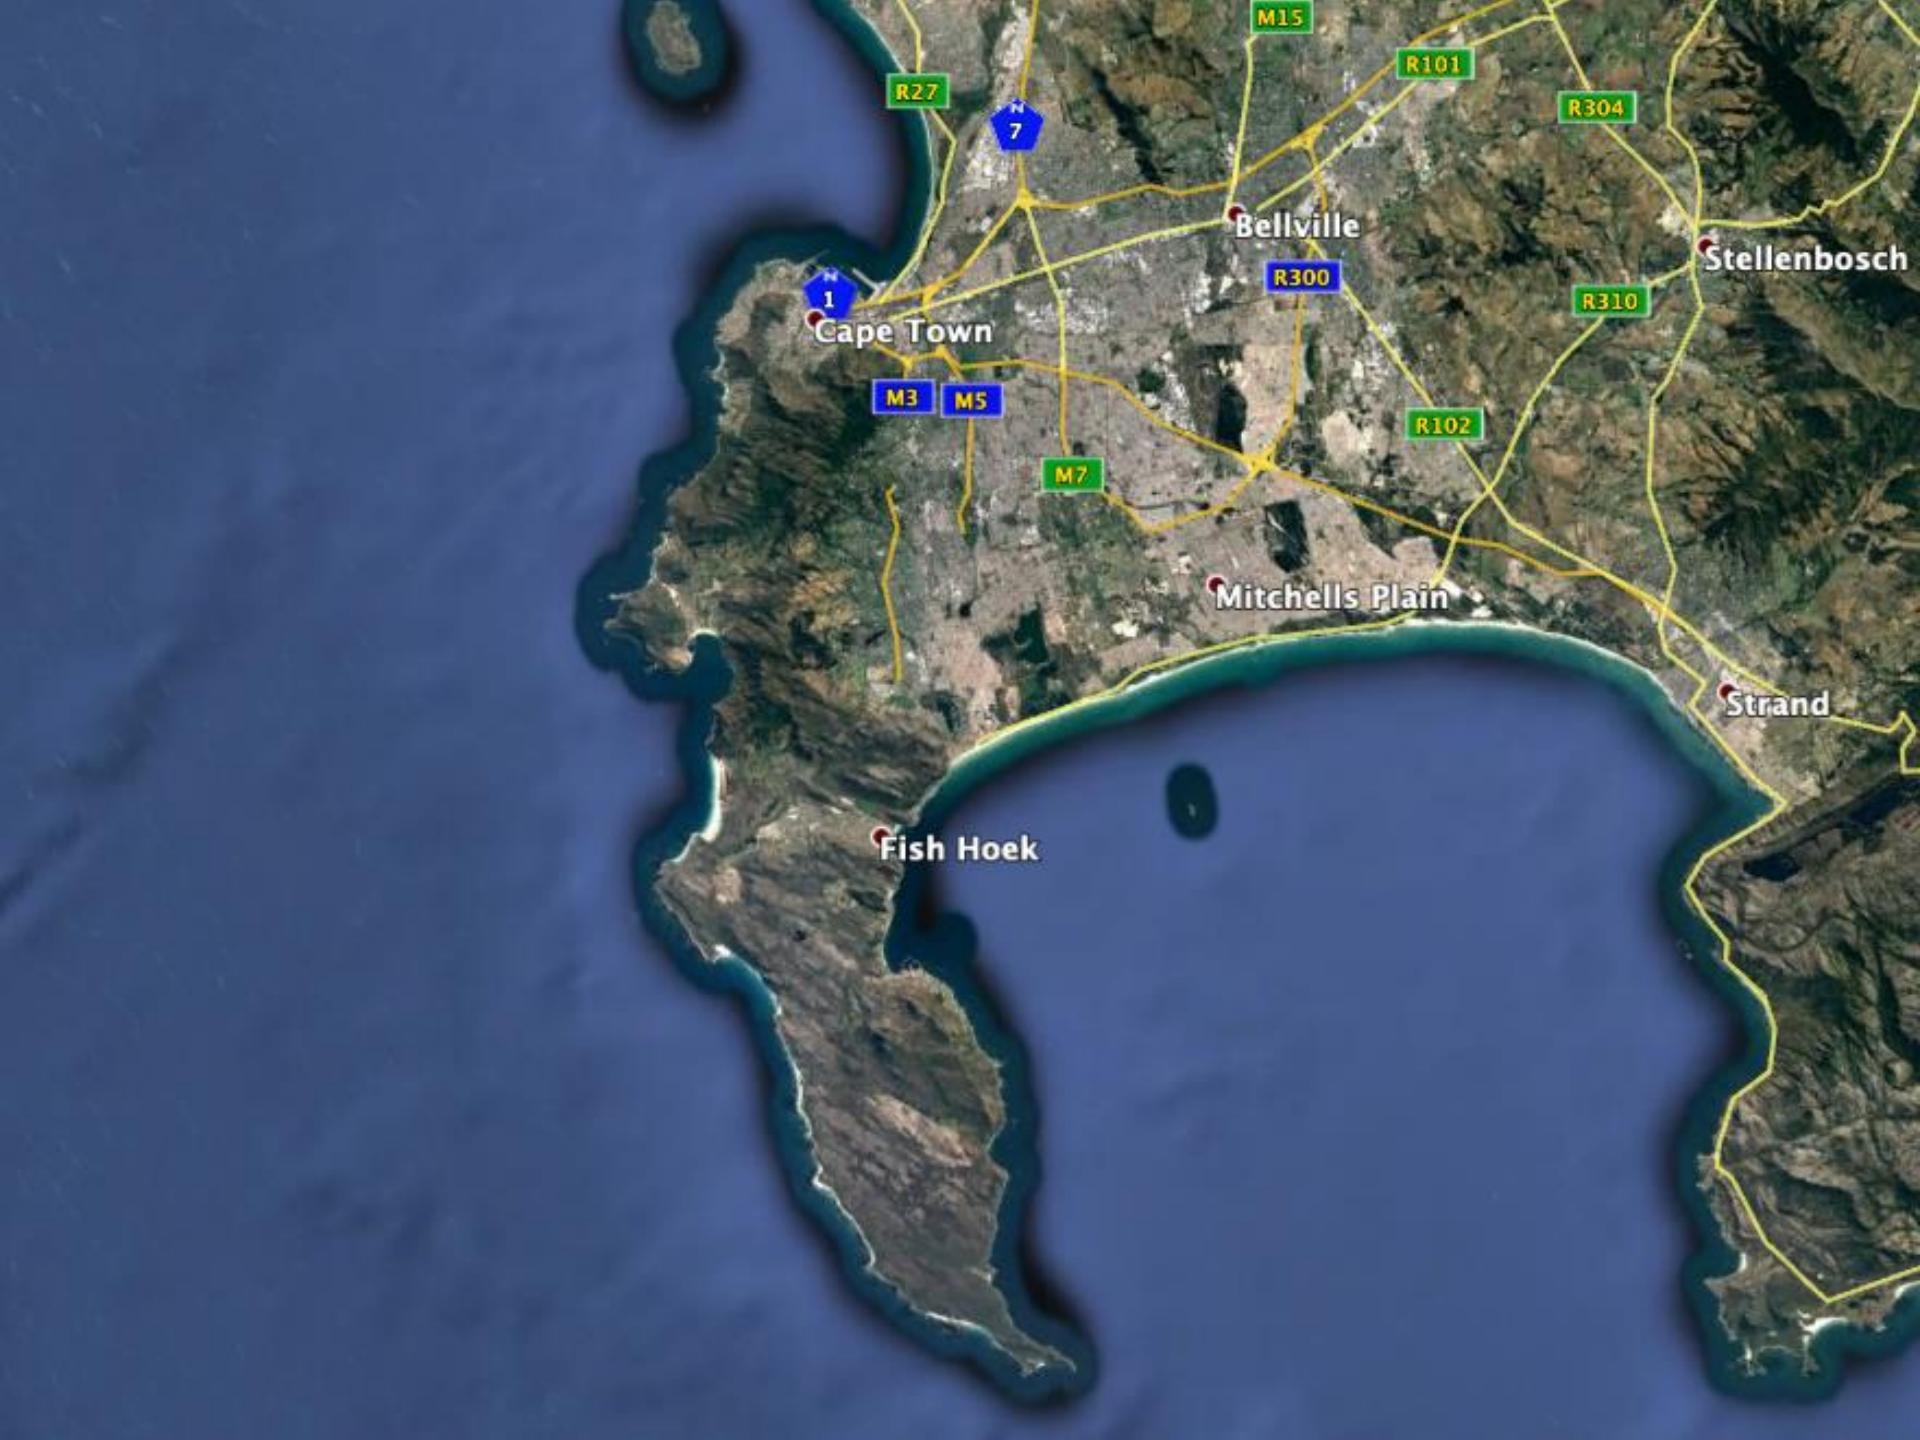
Path of CV24 from the start of Leg 3, along Cape Peninsula

Winds initially out of the NE; began to back as fleet went south.

Breeze freshened from the north, then NNW

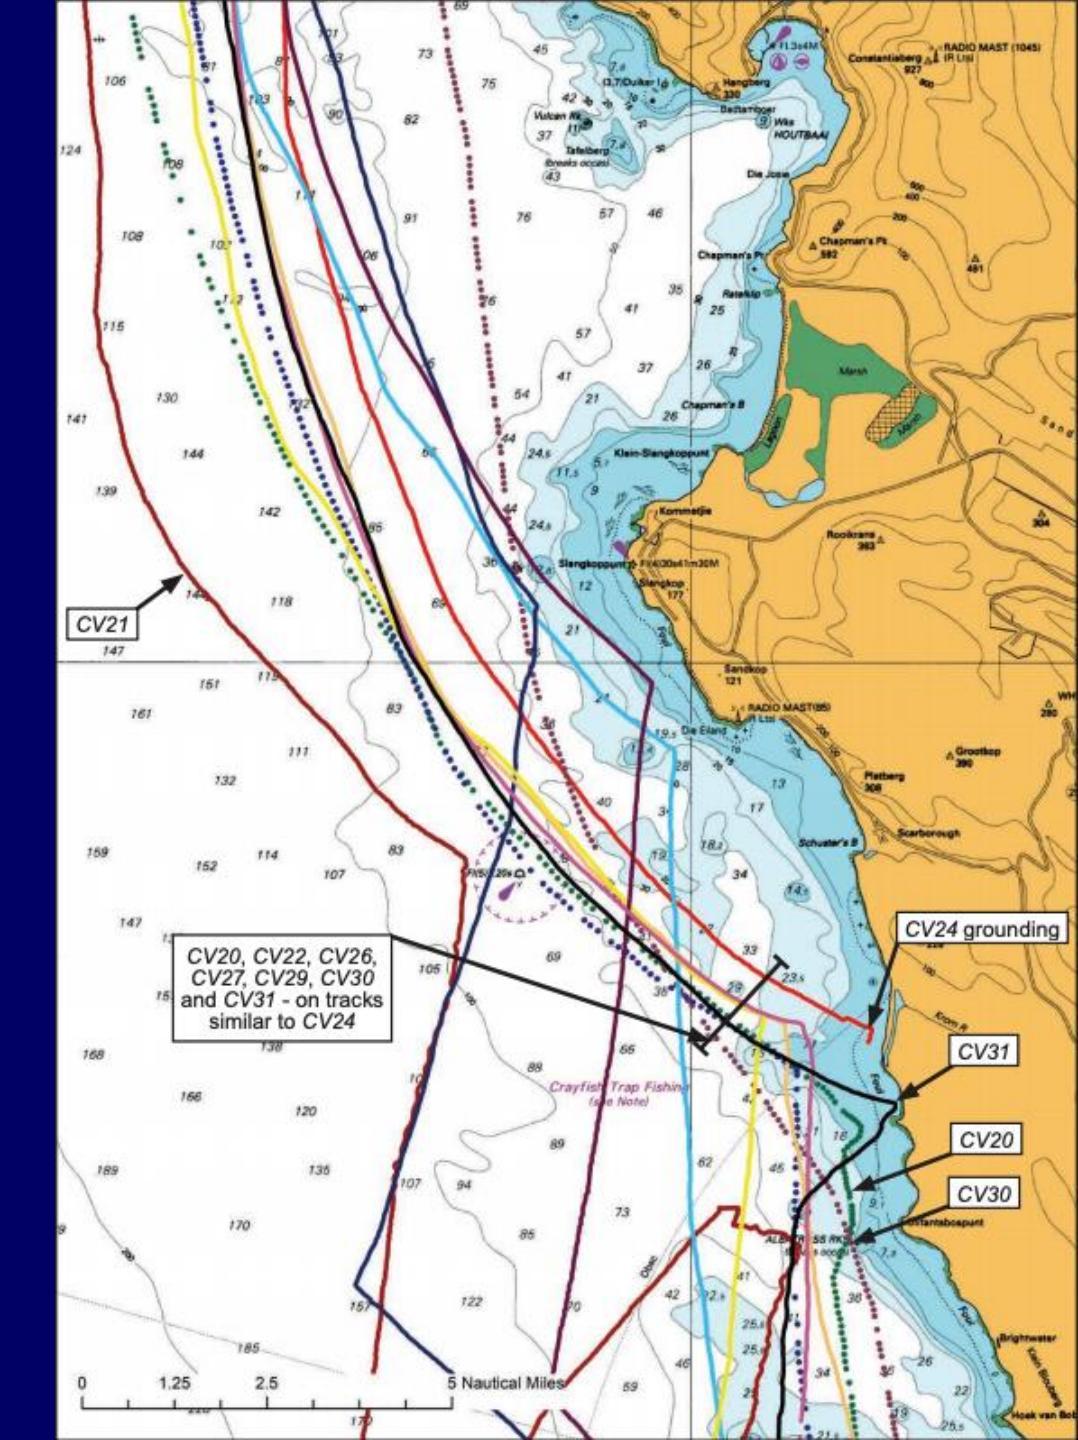
Paths of vessels along Cape Peninsula

- 1. Loss of situational awareness was the proximate cause of the grounding, i.e. navigation was ignored so that the gybe could be safely carried out.
- 2. A lack of a passage plan made it more difficult to determine that the vessel was off-course
- 3. Navigational training was not part of their comprehensive training program.
- 4. Key navigational information was either not displayed or not available on deck.

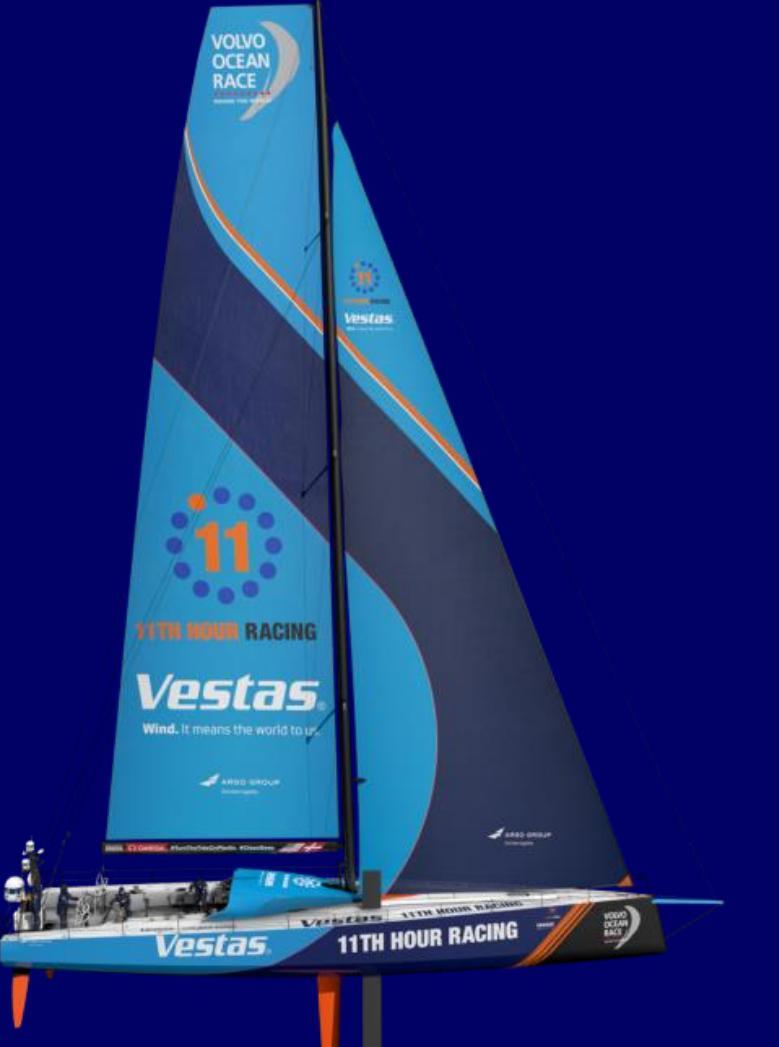
2017-2018 Volvo Ocean Race Collision on Leg 4

Fleet was headed from Melbourne to Hong Kong

TWA of 150, 21kts of boat speed

Encountered a mass of coastal fishing boats

Collision between V11 and one of the boats on her port bow about 30 miles from the finish

The captain of the fishing boat was killed in the collision

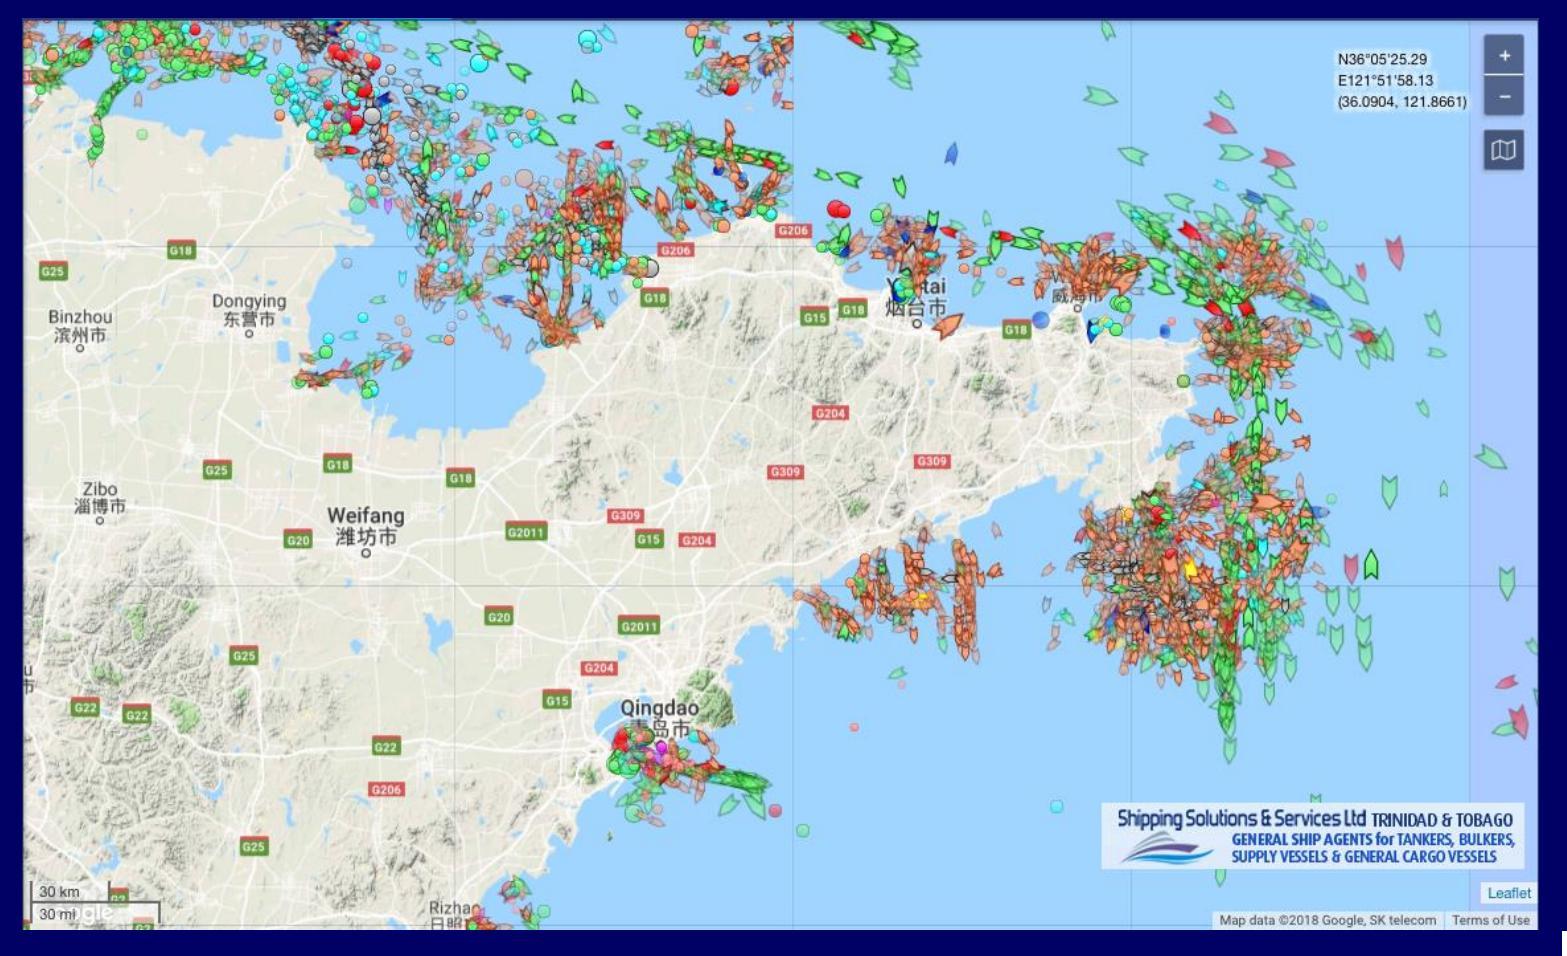
Fishing activity near Qingdao (beige boats are fishing vessels)

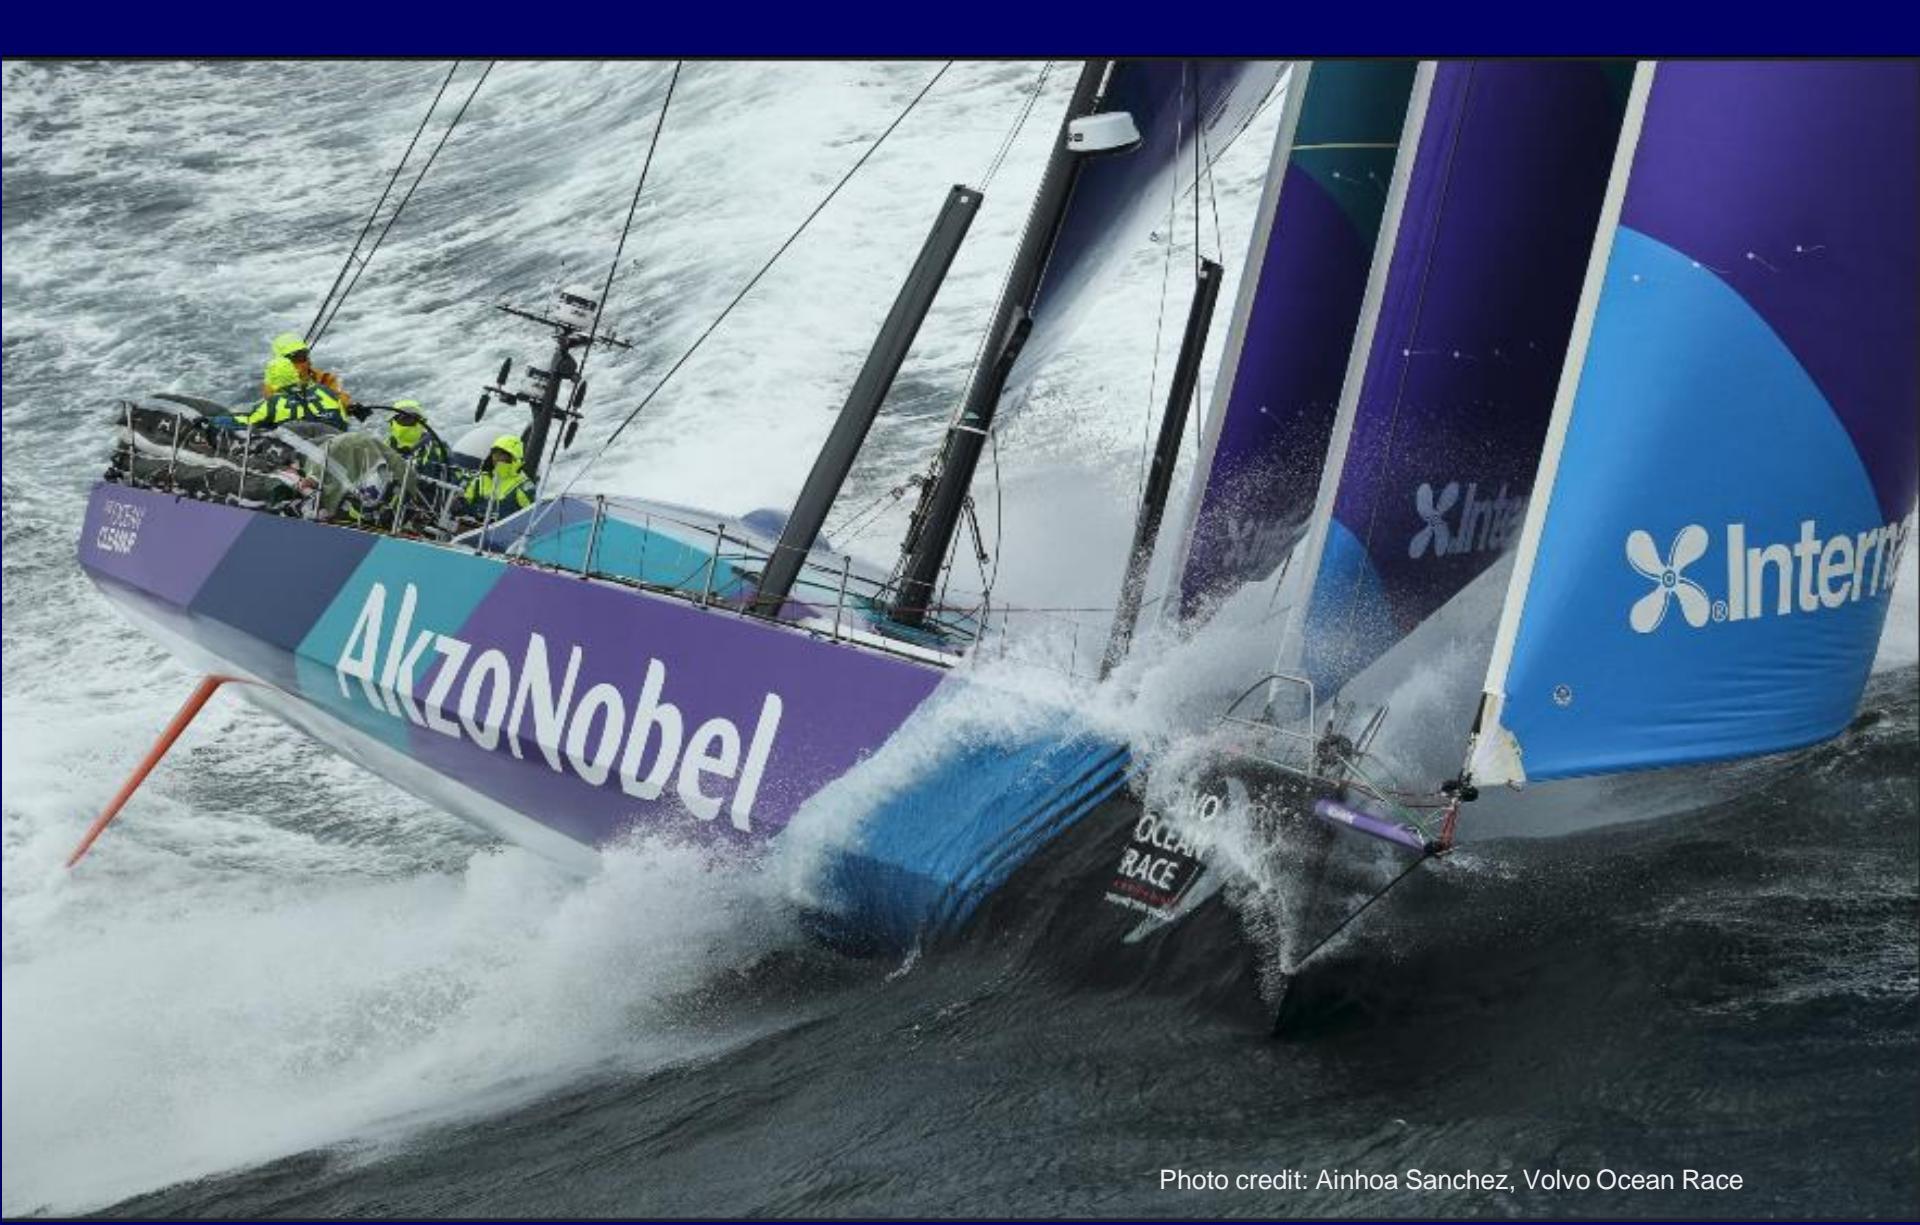
Heel + spray + jibs on the water = tough watchkeeping.

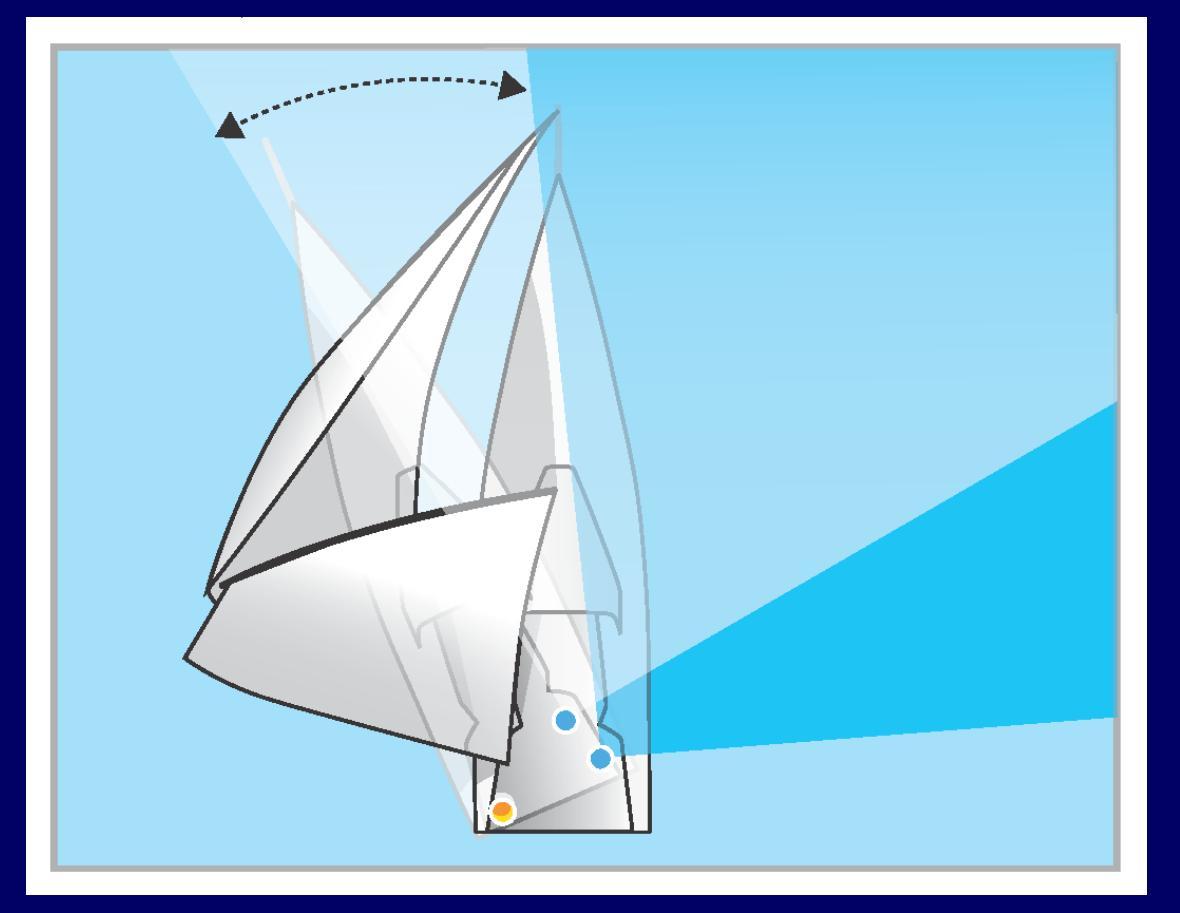
Dipping the Bow

Helmsmen would bear off 10-20 degrees periodically to allow them to see beyond/behind the luff of the headsail

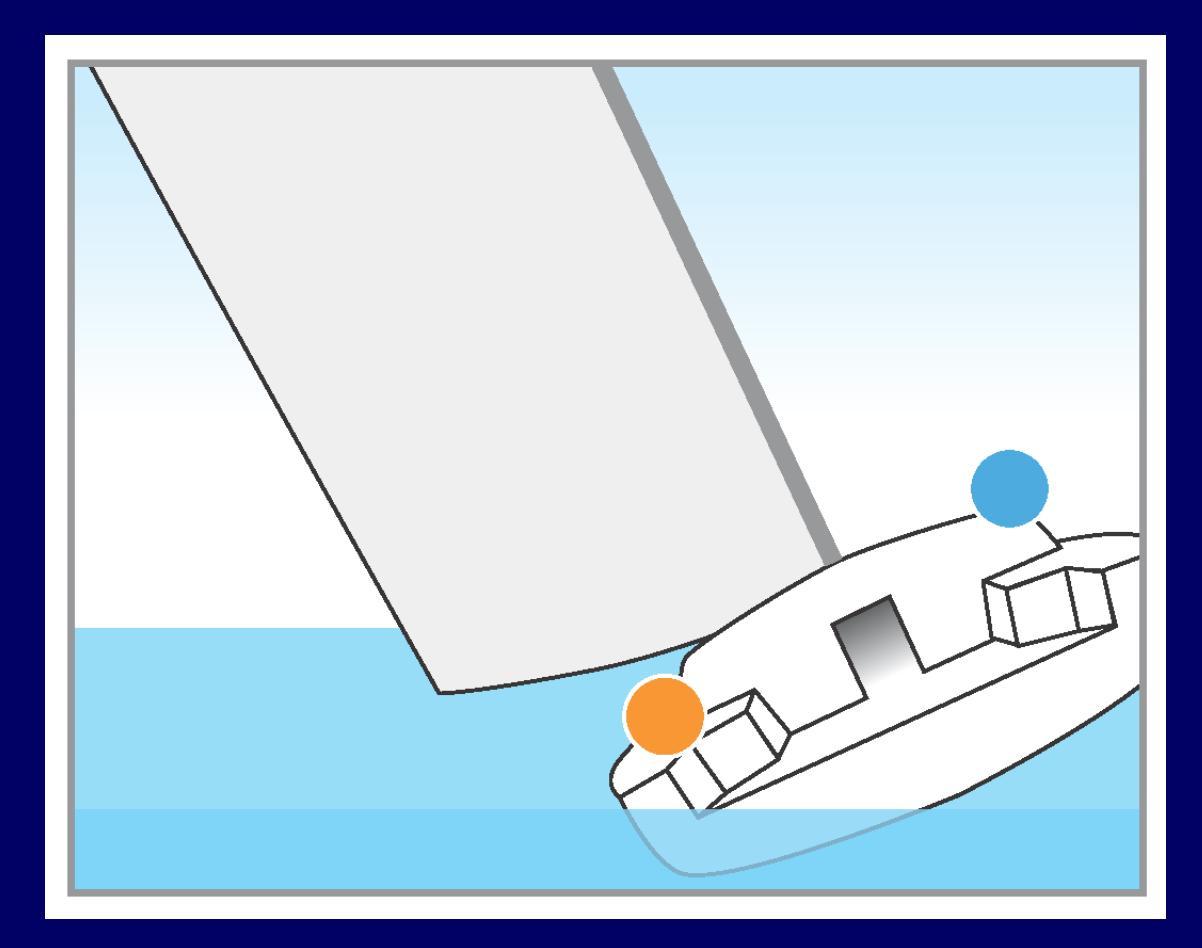
Crew to Leeward

Watch captains position a grinder or an extra crewmember to leeward to wait for an opportunity to view what is under the sail

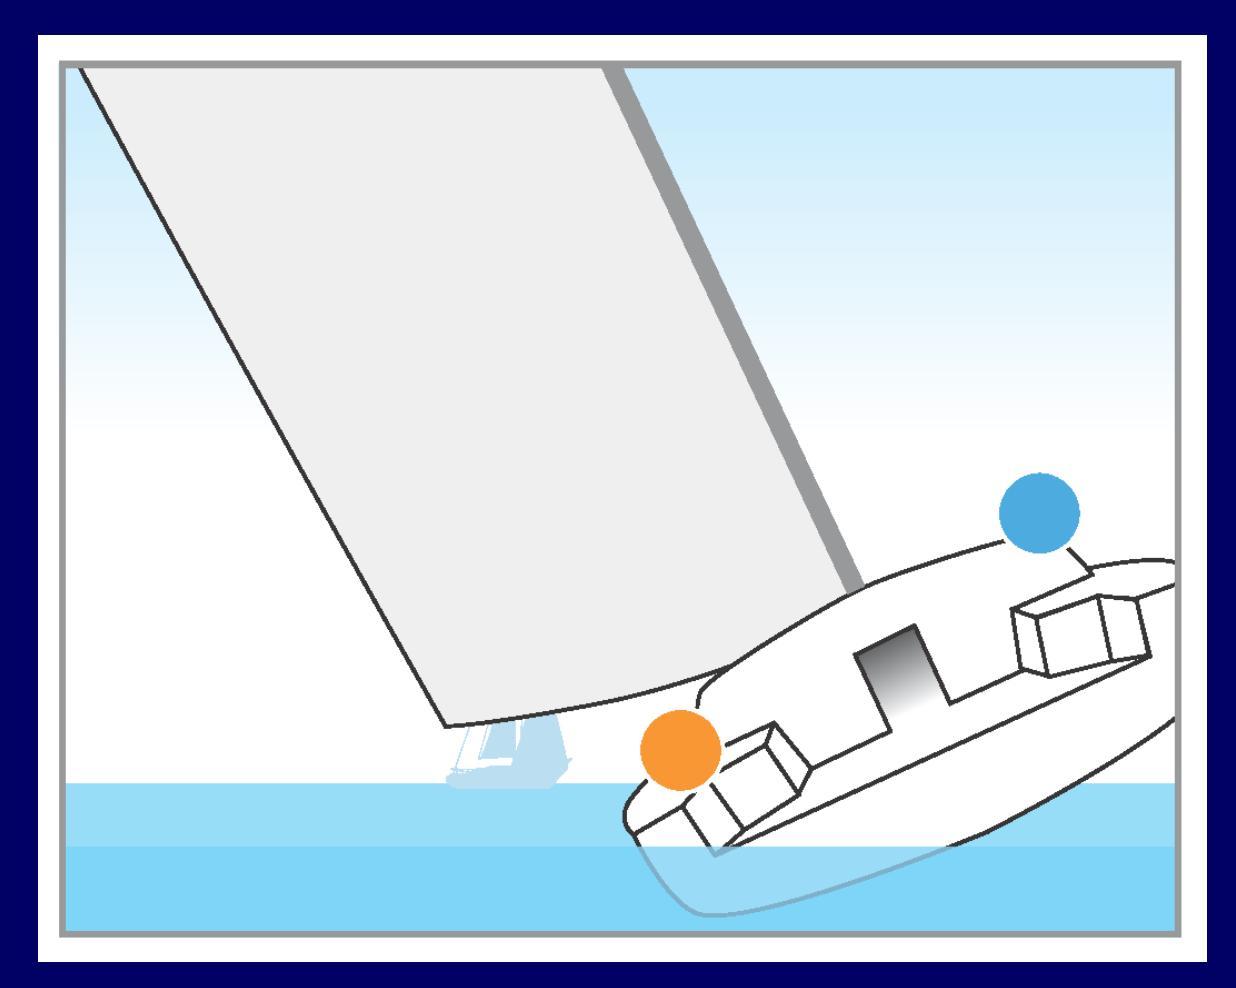
Timing is everything

Crews to leeward in the cockpit would have to wait for the sailboat to be on a crest to get the best view

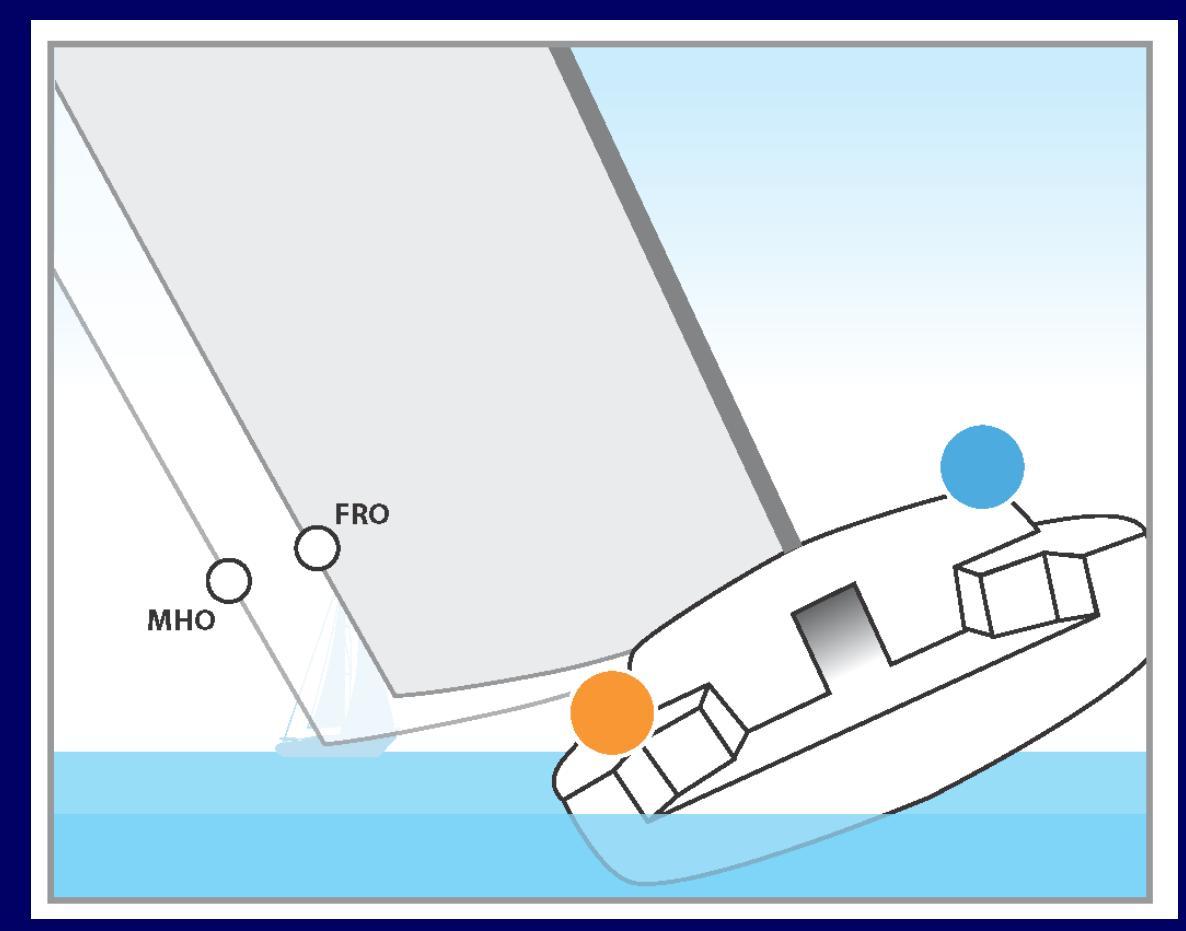
Less overlap = more visibility

Crews indicated that the A3 and MHO, due to their overlap, presented the greatest visibility issues. Shorter LP sails, like the FRO, were easier to see around.
